# Access Compliance Report

## Public Rights-of-Way

### (Curb Ramps)

Intersection ID: 42924	Main Street: BRAY_DR	Cross Street: KILRUSH_DR	Location:	S
ADA ID: C4267121DF00	Ramp Type: PerpDiag	Initial Pass/Fail: Fail	Overall Compliance: No	Severity Score: 22.5
Codes/Mitigation Info/Possible Solution		Field Measurements/Component Compliance

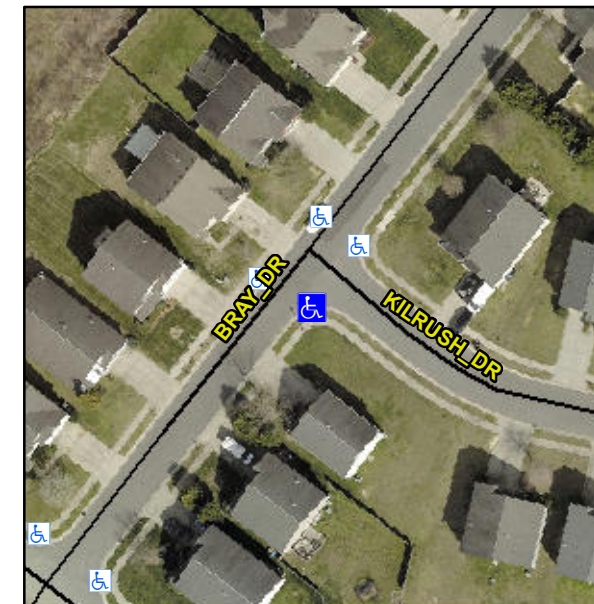
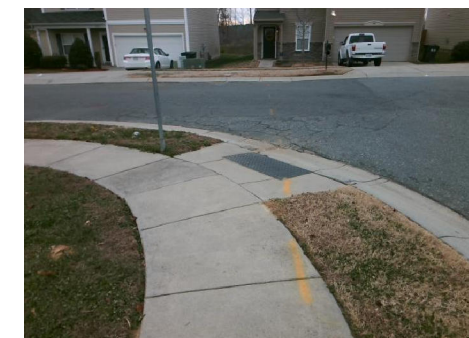
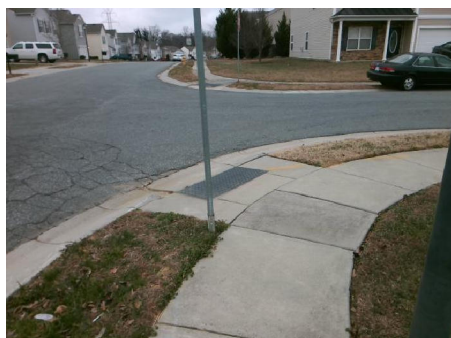
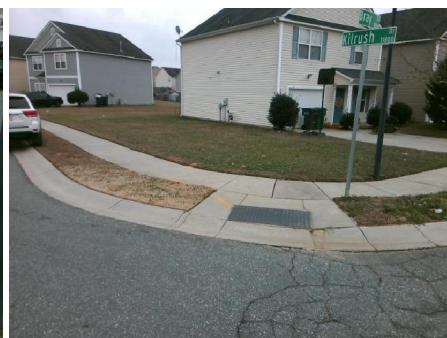
Compliance	Description	Data	Compliance	Description	Data
N/A	Ramp Length (in)	44.0	No	Ramp Slope (%)	8.4
No	Ramp Width (in)	39.0	No	Ramp XSlope (%)	2.6
N/A	Flare Type LT	N/A	N/A	Flare Type RT	N/A
N/A	Flare Slope LT (%)	N/A	N/A	Flare Slope RT (%)	N/A
N/A	Flare Traversable LT?	N/A	N/A	Flare Traversable RT?	N/A
N/A	Landing Length (in)	N/A	N/A	DWS Provided?	N/A
N/A	Landing Width (in)	N/A	N/A	DWS Contrast?	N/A
N/A	Landing Slope (%)	N/A	N/A	DWS Length (in)	N/A
N/A	Landing X Slope (%)	N/A	N/A	DWS Full Width?	N/A
N/A	Landing Curb? (Y/N)	N/A	N/A	DWS Offset (in)	N/A
N/A	Shared Landing?	N/A			
N/A	Gutter Ponding?	N/A	N/A	Gutter Slope (%)	N/A
N/A	Gutter Lip Ht (in)	N/A	N/A	Gutter X Slope (%)	N/A
N/A	Painted X Walk1?	No	N/A	Painted X Walk2?	No
	X Walk 1 Direction	To NE		X Walk 2 Direction	To NW
N/A	X Walk 1 Width (in)	N/A	N/A	X Walk 2 Width (in)	N/A
	X Walk 1 Slope (%)	4.6		X Walk 2 Slope (%)	2.4
	X Walk 1 X Slope (%)	1.9		X Walk 2 X Slope (%)	2.7

N/A	Ramp inside XWalk1?	N/A	N/A	Ramp inside XWalk2?	N/A
	Road Slope (%)	2.4	N/A	Clear Space?	N/A
	Road X Slope (%)	4.8	N/A	Clear Space to XWalk (in)	N/A
N/A	Any Obstructions?	N/A	N/A	Storm Grate/Utility Hazard?	N/A
	Obstruction Type			Storm Grate/Utility Type	
		N/A			N/A
			Yes	Surface Condition? (G/P)	Good

Possible Solutions:

**Remove & Replace Curb Ramp With Two New Directional Ramps or Equivalent.**

Total Cost: \$ 3200.00
