Access Compliance Report

Public Rights-of-Way

(Curb Ramps)

Intersection ID: 49004	Main Street: LITTLE_GEM_LN	Cross Street: STEELECROFT_PY	Location: SW
ADA ID: C437B6DAB3EC	Ramp Type: PerpDiag	Initial Pass/Fail: Fail	Overall Compliance: No
			Severity Score: 21.25

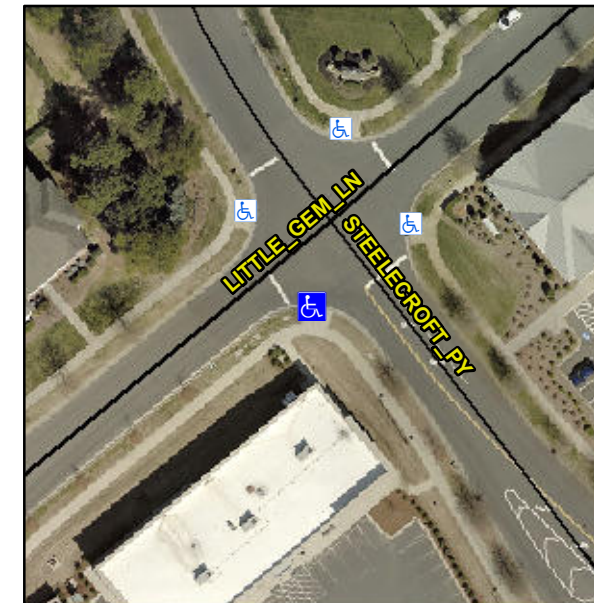
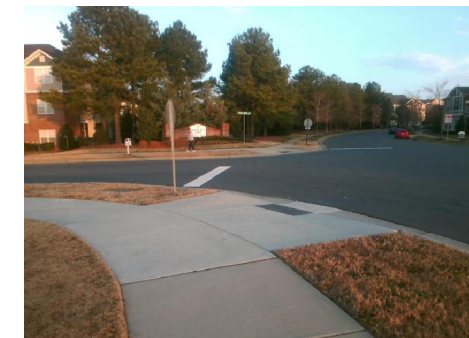
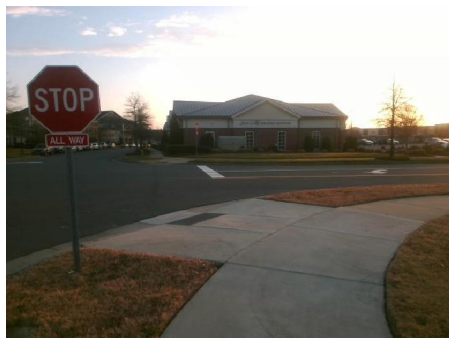
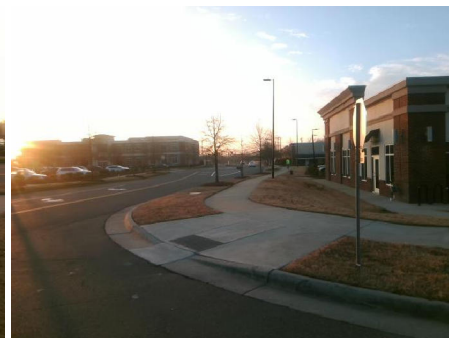
Not Found, R304.5.1, R304.2.2

Compliance	Description	Data	Compliance	Description	Data
N/A	Ramp Length (in)	98.0	No	Ramp Slope (%)	9.7
No	Ramp Width (in)	47.0	Yes	Ramp XSlope (%)	1.1
N/A	Flare Type LT	N/A	N/A	Flare Type RT	N/A
N/A	Flare Slope LT (%)	N/A	N/A	Flare Slope RT (%)	N/A
N/A	Flare Traversable LT?	N/A	N/A	Flare Traversable RT?	N/A
N/A	Landing Length (in)	N/A	N/A	DWS Provided?	N/A
N/A	Landing Width (in)	N/A	N/A	DWS Contrast?	N/A
N/A	Landing Slope (%)	N/A	N/A	DWS Length (in)	N/A
N/A	Landing X Slope (%)	N/A	N/A	DWS Full Width?	N/A
N/A	Landing Curb? (Y/N)	N/A	N/A	DWS Offset (in)	N/A
N/A	Shared Landing?	N/A			
N/A	Gutter Ponding?	N/A	N/A	Gutter Slope (%)	N/A
N/A	Gutter Lip Ht (in)	N/A	N/A	Gutter X Slope (%)	N/A
N/A	Painted X Walk1?	No	N/A	Painted X Walk2?	No
	X Walk 1 Direction	To NE		X Walk 2 Direction	To NW
N/A	X Walk 1 Width (in)	N/A	N/A	X Walk 2 Width (in)	N/A
	X Walk 1 Slope (%)	0.3		X Walk 2 Slope (%)	1.1
	X Walk 1 X Slope (%)	1.4		X Walk 2 X Slope (%)	1.9

N/A	Ramp inside XWalk1?	N/A	N/A	Ramp inside XWalk2?	N/A
	Road Slope (%)	1.2	N/A	Clear Space?	N/A
	Road X Slope (%)	0.5	N/A	Clear Space to XWalk (in)	N/A
N/A	Any Obstructions?	N/A	N/A	Storm Grate/Utility Hazard?	N/A
	Obstruction Type			Storm Grate/Utility Type	
		N/A			N/A
			Yes	Surface Condition? (G/P)	Good

Remove & Replace Curb Ramp With Two New Directional Ramps or Equivalent.
