Access Compliance Report

Public Rights-of-Way

(Curb Ramps)

Intersection ID: 27418	Main Street: BALLANTYNE_COMMONS_PY	Cross Street: BALLANTYNE_TRACE_CT	Location: NW
ADA ID: C4389B9A9553	Ramp Type: Perp	Initial Pass/Fail: Fail	Overall Compliance: No
		Severity Score: 8.75

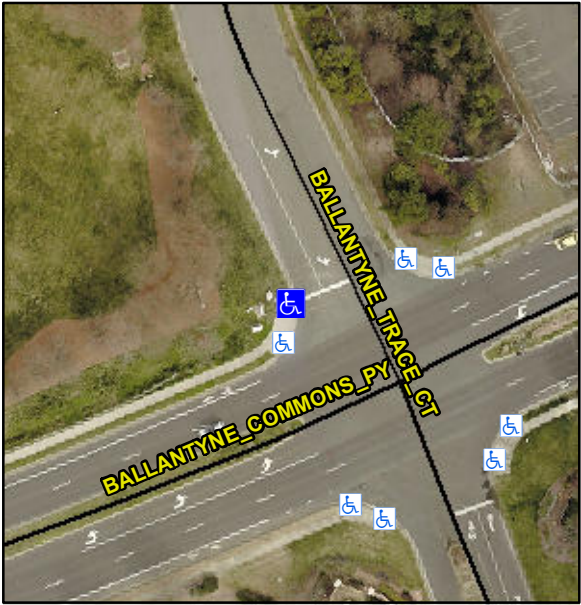
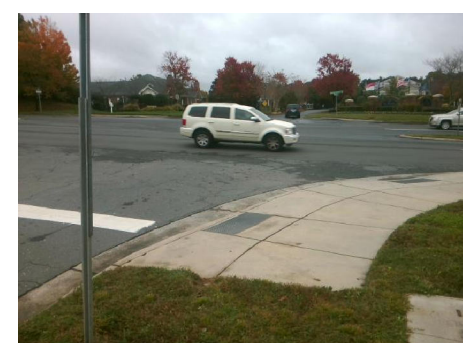
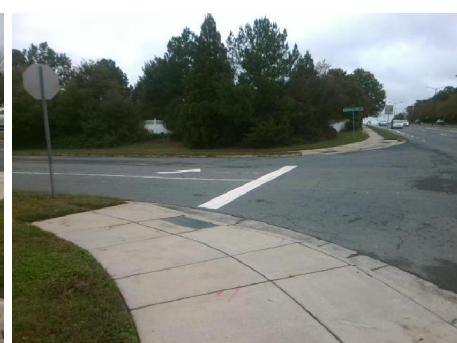
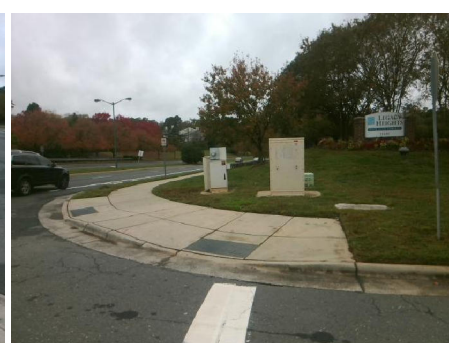
Possible Solutions:		Compliance	Description	Data
	Remove & Replace Entire Ramp.		N/A	Ramp Length (in)	108.0
			No	Ramp Width (in)	47.0
			N/A	Flare Type LT	N/A
			N/A	Flare Slope LT (%)	N/A
			N/A	Flare Traversable LT?	N/A
			N/A	Landing Length (in)	N/A
			N/A	Landing Width (in)	N/A
			N/A	Landing Slope (%)	N/A
			N/A	Landing X Slope (%)	N/A
<p>Surveyor Notes:</p> <p>N/A</p> <p>PROW/ADA:</p> <p>Not Found, R304.5.1</p>			N/A	Flare Type RT	N/A
			N/A	Flare Slope RT (%)	N/A
			N/A	Flare Traversable RT?	N/A
			N/A	DWS Provided?	N/A
			N/A	DWS Contrast?	N/A
			N/A	DWS Length (in)	N/A
			N/A	DWS Full Width?	N/A
			N/A	DWS Offset (in)	N/A
			N/A	Gutter Ponding?	N/A
			N/A	Gutter Lip Ht (in)	N/A
			N/A	Painted X Walk1?	No
				X Walk 1 Direction	To E
			N/A	X Walk 1 Width (in)	N/A
				X Walk 1 Slope (%)	5.8
				X Walk 1 X Slope (%)	3.3

N/A	Ramp inside XWalk1?	N/A
				Road Slope (%)	N/A
				Road X Slope (%)	N/A
			N/A	Any Obstructions?	N/A
				Obstruction Type	
Total Cost:			\$	1850.00	
			N/A		
			N/A		
			Yes	Surface Condition? (G/P)	Good
