# Access Compliance Report

## Public Rights-of-Way

### (Curb Ramps)

Intersection ID: 53160	Main Street: PERTH_MOOR_RD	Cross Street: HAMILTON_BRIDGE_RD	Location: SW
ADA ID: C43D68DF350A	Ramp Type: Perp	Initial Pass/Fail: Fail	Overall Compliance: No
Severity Score: 21.25			
Codes/Mitigation Info/Possible Solution		Field Measurements/Component Compliance

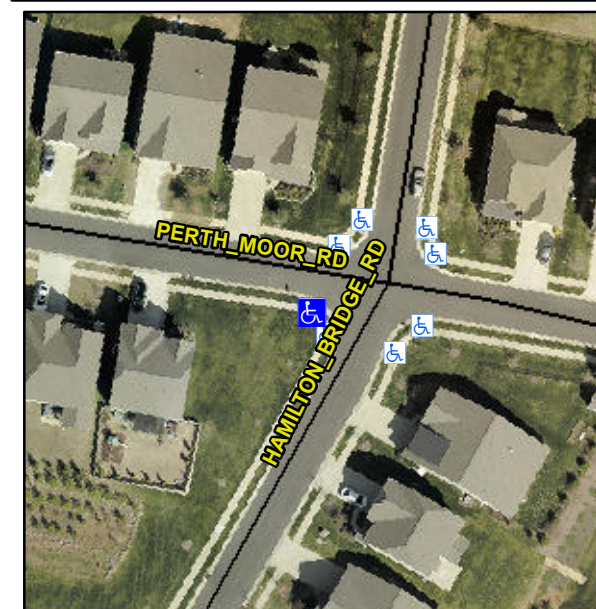
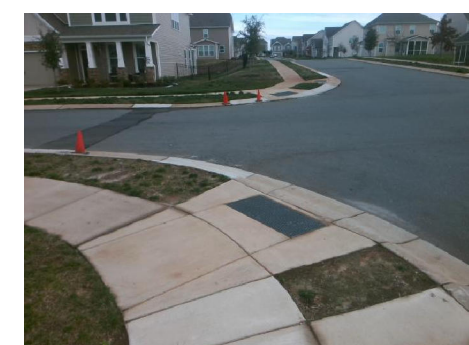
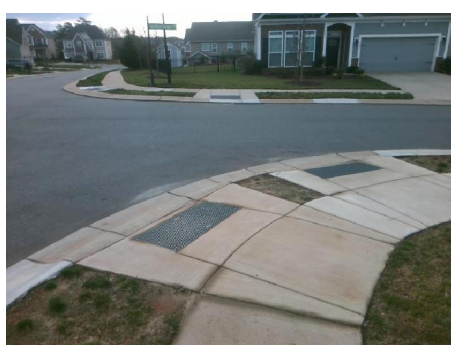
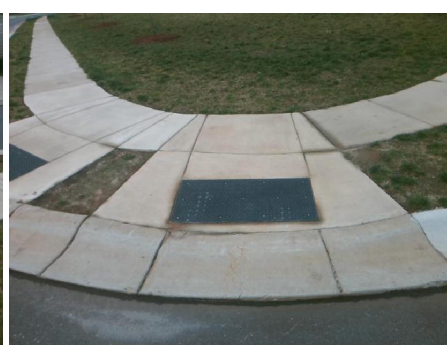
Compliance	Description	Data	Compliance	Description	Data
N/A	Ramp Length (in)	49.0	No	Ramp Slope (%)	8.8
No	Ramp Width (in)	46.0	Yes	Ramp XSlope (%)	0.8
N/A	Flare Type LT	N/A	N/A	Flare Type RT	N/A
N/A	Flare Slope LT (%)	N/A	N/A	Flare Slope RT (%)	N/A
N/A	Flare Traversable LT?	N/A	N/A	Flare Traversable RT?	N/A
N/A	Landing Length (in)	N/A	N/A	DWS Provided?	N/A
N/A	Landing Width (in)	N/A	N/A	DWS Contrast?	N/A
N/A	Landing Slope (%)	N/A	N/A	DWS Length (in)	N/A
N/A	Landing X Slope (%)	N/A	N/A	DWS Full Width?	N/A
N/A	Landing Curb? (Y/N)	N/A	N/A	DWS Offset (in)	N/A
N/A	Shared Landing?	N/A			
N/A	Gutter Ponding?	N/A	N/A	Gutter Slope (%)	N/A
N/A	Gutter Lip Ht (in)	2.0	N/A	Gutter X Slope (%)	N/A
N/A	Painted X Walk1?	No	N/A	Painted X Walk2?	N/A
	X Walk 1 Direction	To NE		X Walk 2 Direction	N/A
N/A	X Walk 1 Width (in)	N/A	N/A	X Walk 2 Width (in)	N/A
	X Walk 1 Slope (%)	4.4		X Walk 2 Slope (%)	N/A
	X Walk 1 X Slope (%)	0.2		X Walk 2 X Slope (%)	N/A

N/A	Ramp inside XWalk1?	N/A	N/A	Ramp inside XWalk2?	N/A
	Road Slope (%)	N/A	N/A	Clear Space?	N/A
	Road X Slope (%)	N/A	N/A	Clear Space to XWalk (in)	N/A
N/A	Any Obstructions?	N/A	N/A	Storm Grate/Utility Hazard?	N/A
	Obstruction Type			Storm Grate/Utility Type	
		N/A			N/A
		Yes		Surface Condition? (G/P)	Good

Possible Solutions:

**Remove & Replace Entire Ramp.**
