Access Compliance Report Public Rights-of-Way (Curb Ramps)

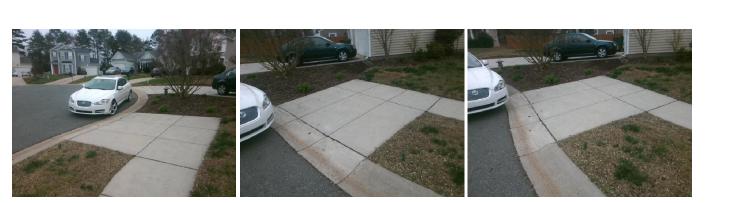
Intersection ID: 10021371	Main Str	Main Street: BLUE_BRIDGE_CT				N/A	Location:	SW		
ADA ID: C43FBB5307BD	Ramp Type: Perp				Initial Pass/Fail: Fail Overall Compliance: No				o Severity Score:	21.25
Codes/Mitigation Info/Possible Solution					Field Measurements/Component Compliance					
	W ASSAULT	Possible Solutions:							liance Description	Data
	The same	Remove & R	eplace Entire Ran	n	N/A	Ramp Length (in)	83.0	Yes	Ramp Slope (%)	7.0

- LAAN			.b.	No	Ramp Width (in)	43.0		Ramp XSlope (%)	5.4
	1 All and				N/A	Flare Type LT	N/A	N/A	Flare Type RT	N/A
					N/A	Flare Slope LT (%)		N/A	Flare Slope RT (%)	N/A
					N/A	Flare Traversable LT?	N/A	N/A	Flare Traversable RT?	N/A
I The state					N/A	Landing Length (in)	N/A	N/A	DWS Provided?	N/A
THE SUL	7	Surveyor Notes:			N/A	Landing Width (in)	N/A	N/A	DWS Contrast?	N/A
the average of the	and the	N/A			N/A	Landing Slope (%)	N/A	N/A	DWS Length (in)	N/A
Fill Eller	ha Con	IN/A			N/A	Landing X Slope (%)	N/A	N/A	DWS Full Width?	N/A
					N/A	Landing Curb? (Y/N)	N/A	N/A	DWS Offset (in)	N/A
	16 1 1				N/A	Shared Landing?	N/A		DWG Oliset (III)	11/2
A CL					N/A	0	N/A	N/A	Cuttor Slope (9/)	N/A
and the	A AN AN	PROW/ADA:				Gutter Ponding?			Gutter Slope (%)

1. 1.	Not Found,	R304.5.1, R304.5.3	3	N/A	Gutter Lip Ht (in)	N/A	N/A	Gutter X Slope (%)	N/A
					N/A	Painted X Walk1?	No 	N/A	Painted X Walk2?	N/A
1 2 6 3	1 V 1					X Walk 1 Direction	To N		X Walk 2 Direction	N/A
	A A A				N/A	X Walk 1 Width (in)	N/A	N/A	X Walk 2 Width (in)	N/A
Street 1 Name	BLUE BRIDGE CT					X Walk 1 Slope (%)	7.3		X Walk 2 Slope (%)	N/A
Stop Condition-Street 2	None					X Walk 1 X Slope (%)	5.5		X Walk 2 X Slope (%)	N/A
Street 2 Name	N/A				N/A	Ramp inside XWalk1?	N/A	N/A	Ramp inside XWalk2?	N/A
Stop Condition-Street 1	N/A					Road Slope (%)	5.5	N/A	Clear Space?	N/A
						Road X Slope (%)	7.3	N/A	Clear Space to XWalk (in)	N/A
					N/A	Any Obstructions?	N/A	N/A	Storm Grate/Utility Hazard?	N/A
		Total Cost:	\$	1850.00		Obstruction Type			Storm Grate/Utility Type	
							N/A			N/A
