# Access Compliance Report

## Public Rights-of-Way

### (Curb Ramps)

Intersection ID: 45495	Main Street: COTTON_PRESS_RD	Cross Street: TREE_CANOPY_RD	Location: N
ADA ID: C442137A3D52	Ramp Type: PerpDiag	Initial Pass/Fail: Fail	Overall Compliance: No
Severity Score: 26.25			
Codes/Mitigation Info/Possible Solution		Field Measurements/Component Compliance

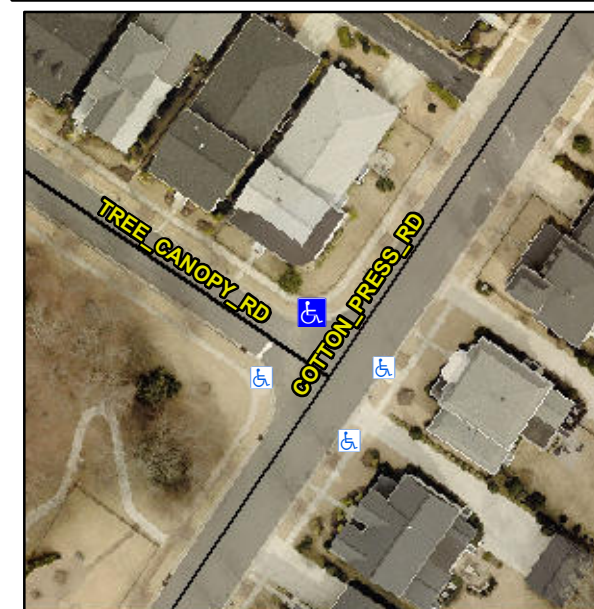
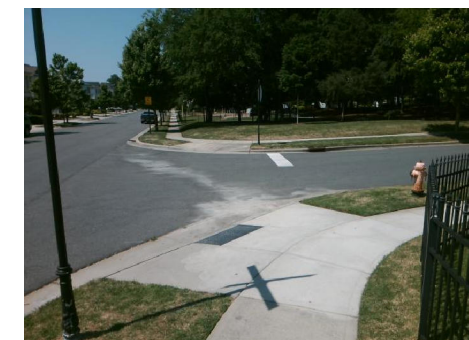
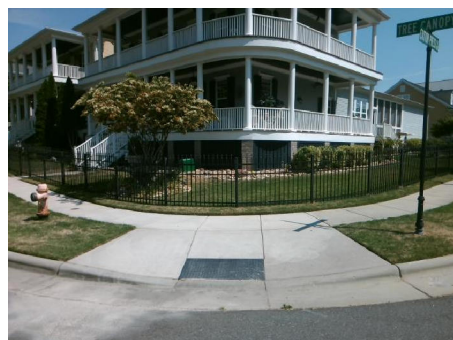
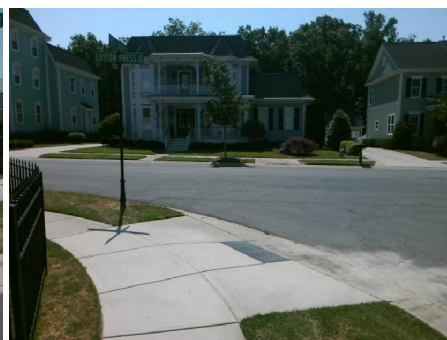
**Not Found, R304.2.2, R304.5.3**

Compliance	Description	Data	Compliance	Description	Data
N/A	Ramp Length (in)	69.0	No	Ramp Slope (%)	16.2
Yes	Ramp Width (in)	48.0	No	Ramp XSlope (%)	3.1
N/A	Flare Type LT	N/A	N/A	Flare Type RT	N/A
N/A	Flare Slope LT (%)	N/A	N/A	Flare Slope RT (%)	N/A
N/A	Flare Traversable LT?	N/A	N/A	Flare Traversable RT?	N/A
N/A	Landing Length (in)	N/A	N/A	DWS Provided?	N/A
N/A	Landing Width (in)	N/A	N/A	DWS Contrast?	N/A
N/A	Landing Slope (%)	N/A	N/A	DWS Length (in)	N/A
N/A	Landing X Slope (%)	N/A	N/A	DWS Full Width?	N/A
N/A	Landing Curb? (Y/N)	N/A	N/A	DWS Offset (in)	N/A
N/A	Shared Landing?	N/A			
N/A	Gutter Ponding?	N/A	N/A	Gutter Slope (%)	N/A
N/A	Gutter Lip Ht (in)	N/A	N/A	Gutter X Slope (%)	N/A
N/A	Painted X Walk1?	No	N/A	Painted X Walk2?	No
	X Walk 1 Direction	To SW		X Walk 2 Direction	To SE
N/A	X Walk 1 Width (in)	N/A	N/A	X Walk 2 Width (in)	N/A
	X Walk 1 Slope (%)	2.6		X Walk 2 Slope (%)	4.1
	X Walk 1 X Slope (%)	0.4		X Walk 2 X Slope (%)	0.1

N/A	Ramp inside XWalk1?	N/A	N/A	Ramp inside XWalk2?	N/A
	Road Slope (%)	0.8	N/A	Clear Space?	N/A
	Road X Slope (%)	0.9	N/A	Clear Space to XWalk (in)	N/A
N/A	Any Obstructions?	N/A	N/A	Storm Grate/Utility Hazard?	N/A
	Obstruction Type			Storm Grate/Utility Type	
		N/A			N/A
		Yes		Surface Condition? (G/P)	Good

**Remove & Replace Curb Ramp With Two New Directional Ramps or Equivalent.**
