Access Compliance Report

Public Rights-of-Way

(Curb Ramps)

Intersection ID: 29960	Main Street: CANIPE_DR	Cross Street: DAVIS_CROSSING_CT	Location: S
ADA ID: C44E58B7ED39	Ramp Type: Perp	Initial Pass/Fail: Fail	Overall Compliance: No
		Severity Score: 8.75

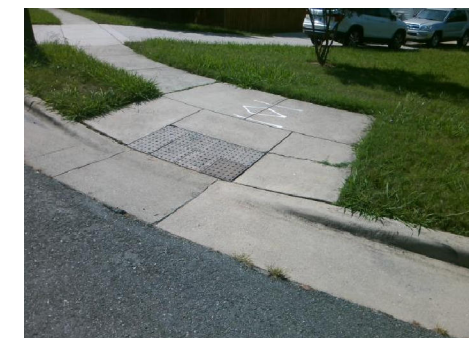
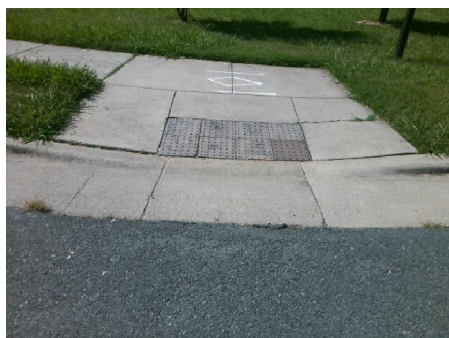
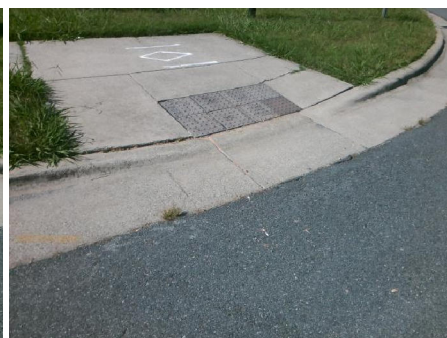
Not Found, R304.5.1

Compliance	Description	Data	Compliance	Description	Data
N/A	Ramp Length (in)	48.0	Yes	Ramp Slope (%)	7.8
No	Ramp Width (in)	40.5	Yes	Ramp XSlope (%)	1.1
N/A	Flare Type LT	N/A	N/A	Flare Type RT	N/A
N/A	Flare Slope LT (%)	N/A	N/A	Flare Slope RT (%)	N/A
N/A	Flare Traversable LT?	N/A	N/A	Flare Traversable RT?	N/A
N/A	Landing Length (in)	N/A	N/A	DWS Provided?	N/A
N/A	Landing Width (in)	N/A	N/A	DWS Contrast?	N/A
N/A	Landing Slope (%)	N/A	N/A	DWS Length (in)	N/A
N/A	Landing X Slope (%)	N/A	N/A	DWS Full Width?	N/A
N/A	Landing Curb? (Y/N)	N/A	N/A	DWS Offset (in)	N/A
N/A	Shared Landing?	N/A			
N/A	Gutter Ponding?	N/A	N/A	Gutter Slope (%)	N/A
N/A	Gutter Lip Ht (in)	N/A	N/A	Gutter X Slope (%)	N/A
N/A	Painted X Walk1?	No	N/A	Painted X Walk2?	N/A
	X Walk 1 Direction	To NW		X Walk 2 Direction	N/A
N/A	X Walk 1 Width (in)	N/A	N/A	X Walk 2 Width (in)	N/A
	X Walk 1 Slope (%)	2.3		X Walk 2 Slope (%)	N/A
	X Walk 1 X Slope (%)	4.1		X Walk 2 X Slope (%)	N/A

N/A	Ramp inside XWalk1?	N/A	N/A	Ramp inside XWalk2?	N/A
	Road Slope (%)	N/A	N/A	Clear Space?	N/A
	Road X Slope (%)	N/A	N/A	Clear Space to XWalk (in)	N/A
N/A	Any Obstructions?	N/A	N/A	Storm Grate/Utility Hazard?	N/A
	Obstruction Type			Storm Grate/Utility Type	
		N/A			N/A
			Yes	Surface Condition? (G/P)	Good

Remove & Replace Entire Ramp.

Total Cost: \$ 1850.00
