Access Compliance Report

Public Rights-of-Way

(Curb Ramps)

Intersection ID: 8074	Main Street: KENNESAW_DR	Cross Street: ODESSA_AV	Location:	W
ADA ID: C459B1835514	Ramp Type: Directional	Initial Pass/Fail: Fail	Overall Compliance: No	Severity Score: 25

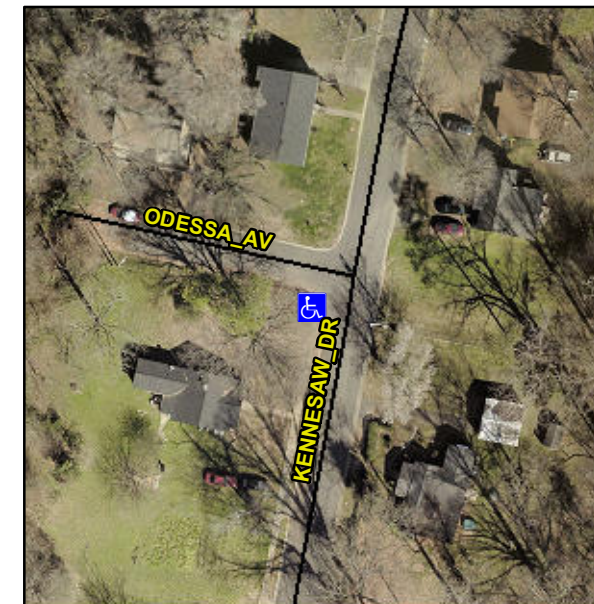
CURB LIP 1.0"

R304.2.2

Compliance	Description	Data	Compliance	Description	Data
N/A	Ramp Length (in)	100.5	N/A	Grade Break?	N/A
Yes	Ramp Width (in)	51.0	N/A	Grade Break Slope (%)	0.0
No	Ramp Slope (%)	12.0	N/A	Grade Break XSlope (%)	0.0
Yes	Ramp XSlope (%)	0.9			
N/A	Flare Type LT	N/A	N/A	Flare Type RT	N/A
N/A	Flare Slope LT (%)	N/A	N/A	Flare Slope RT (%)	0.0
N/A	Flare Traversable LT?	N/A	N/A	Flare Traversable RT?	N/A
N/A	Landing Length (in)	0.0	N/A	DWS Provided?	N/A
N/A	Landing Width (in)	0.0	N/A	DWS Contrast?	N/A
N/A	Landing Slope (%)	0.0	N/A	DWS Length (in)	N/A
N/A	Landing X Slope (%)	0.0	N/A	DWS Full Width?	N/A
N/A	Landing Curb? (Y/N)	N/A	N/A	DWS Offset LT (in)	N/A
N/A	Shared Landing?	N/A	N/A	DWS Offset RT (in)	N/A
N/A	Gutter Ponding?	0.0	N/A	Gutter Slope (%)	N/A
N/A	Gutter Lip Ht (in)	0.0	N/A	Gutter X Slope (%)	N/A
N/A	Painted X Walk1?	No		Road Slope (%)	2.0
	X Walk 1 Direction	N/A		Road X Slope (%)	3.2
	X Walk 1 Width (in)	N/A		Clear Space?	N/A

X Walk 1 Slope (%)	2.0	N/A	Clear Space to XWalk (in)	N/A
	X Walk 1 X Slope (%)	3.2	N/A	Storm Grate/Utility Hazard?	N/A
N/A	Ramp inside XWalk1?	N/A		Storm Grate/Utility Type	
N/A	Any Obstructions?	N/A			N/A
	Obstruction Type		Yes	Surface Condition? (G/P)	Good
			N/A	Curb Slope (%)	31.3

Remove & Replace Entire Ramp.
