## Access Compliance Report Public Rights-of-Way (Curb Ramps)

· · · ·									
Intersection ID: 16295	n ID: 16295 Main Street: MARSH_RD			Street:	STONE_ORCHARD_P	Location:	SE		
ADA ID: C463F1014B96	6 Ramp Type: PerpDiag			Initial Pass/Fail: Fail Overall Compliance: No				o Severity Score:	26.25
Codes/Mitigation Info/Possible Solution				Field Measurements/Component Compliance					
		Possible Solutions:		Compliance Description Data			Compliance Description		Data
the state		Remove & Replace Curb Ramp V Two New Directional Ramps or Equivalent.	Vith	N/A	Ramp Length (in)	78.0	No	Ramp Slope (%)	13.7
A A A A A A A A A A A A A A A A A A A				Yes	Ramp Width (in)	48.0	No	Ramp XSlope (%)	3.4
				N/A	Flare Type LT	N/A	N/A	Flare Type RT	N/A
CARL I LOR I				N/A	Flare Slope LT (%)	N/A	N/A	Flare Slope RT (%)	N/A
	RCHARD			N/A	Flare Traversable LT?	N/A	N/A	Flare Traversable RT?	N/A
the store	NECOU			N/A	Landing Length (in)	N/A	N/A	DWS Provided?	N/A
		Surveyor Notes:		N/A	Landing Width (in)	N/A	N/A	DWS Contrast?	N/A

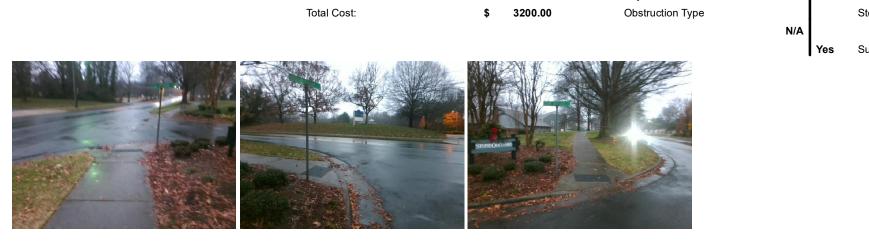
N/A		N/A	Landing Slope (%)	N/A	N/A	DWS Length (in)	N/A
	to bet	1071		N/A	Landing X Slope (%)	N/A	N/A	DWS Full Width?	N/A
				N/A	Landing Curb? (Y/N)	N/A	N/A	DWS Offset (in)	N/A
				N/A	Shared Landing?	N/A			
	St 4. 1 4.	PROW/ADA:		N/A	Gutter Ponding?	N/A	N/A	Gutter Slope (%)	N/A
		R304.2.2, R304.5.3		N/A	Gutter Lip Ht (in)	N/A	N/A	Gutter X Slope (%)	N/A
	ANAL COM			N/A	Painted X Walk1?	No	N/A	Painted X Walk2?	No
					X Walk 1 Direction	To N		X Walk 2 Direction	To W
				N/A	X Walk 1 Width (in)	N/A	N/A	X Walk 2 Width (in)	N/A
Street 1 Name	STONE ORCHARD PL	-			X Walk 1 Slope (%)	2.3		X Walk 2 Slope (%)	3.4
Stop Condition-Street 2	StopSign				X Walk 1 X Slope (%)	2.6		X Walk 2 X Slope (%)	0.2
Street 2 Name	MARSH RD			N/A	Ramp inside XWalk1?	N/A	N/A	Ramp inside XWalk2?	N/A
Stop Condition-Street 1	None				Road Slope (%)	1.6	N/A	Clear Space?	N/A
					Road X Slope (%)	3.3	N/A	Clear Space to XWalk (in)	N/A
				N/A	Any Obstructions?	N/A	N/A	Storm Grate/Utility Hazard?	N/A

Total Cost: \$ 3	200.00		Obstruction Type			Storm Grate/Utility Type	
						N/A			N/A
