Access Compliance Report

Public Rights-of-Way

(Curb Ramps)

Intersection ID: 20860	Main Street: CROWNPOINT_EXECUTIVE_DR	Cross Street: KREFELD_DR	Location:	NE
ADA ID: C4A328A9D5DB	Ramp Type: Perp	Initial Pass/Fail: Fail	Overall Compliance: No	Severity Score: 37.5
Codes/Mitigation Info/Possible Solution		Field Measurements/Component Compliance

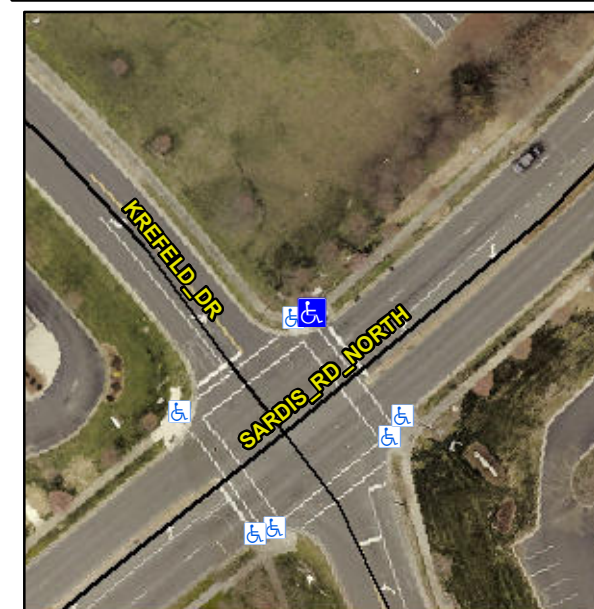
PROW/ADA:

Not Found, R304.2.2, R304.5.3

Compliance	Description	Data	Compliance	Description	Data
N/A	Ramp Length (in)	61.0	No	Ramp Slope (%)	9.3
Yes	Ramp Width (in)	48.0	No	Ramp XSlope (%)	7.9
N/A	Flare Type LT	N/A	N/A	Flare Type RT	N/A
N/A	Flare Slope LT (%)	N/A	N/A	Flare Slope RT (%)	N/A
N/A	Flare Traversable LT?	N/A	N/A	Flare Traversable RT?	N/A
N/A	Landing Length (in)	N/A	N/A	DWS Provided?	N/A
N/A	Landing Width (in)	N/A	N/A	DWS Contrast?	N/A
N/A	Landing Slope (%)	N/A	N/A	DWS Length (in)	N/A
N/A	Landing X Slope (%)	N/A	N/A	DWS Full Width?	N/A
N/A	Landing Curb? (Y/N)	N/A	N/A	DWS Offset (in)	N/A
N/A	Shared Landing?	N/A			
N/A	Gutter Ponding?	N/A	N/A	Gutter Slope (%)	N/A
N/A	Gutter Lip Ht (in)	N/A	N/A	Gutter X Slope (%)	N/A
N/A	Painted X Walk1?	No	N/A	Painted X Walk2?	N/A
	X Walk 1 Direction	To SE		X Walk 2 Direction	N/A
N/A	X Walk 1 Width (in)	N/A	N/A	X Walk 2 Width (in)	N/A
	X Walk 1 Slope (%)	5.6		X Walk 2 Slope (%)	N/A
	X Walk 1 X Slope (%)	3.1		X Walk 2 X Slope (%)	N/A

N/A	Ramp inside XWalk1?	N/A	N/A	Ramp inside XWalk2?	N/A
	Road Slope (%)	N/A	N/A	Clear Space?	N/A
	Road X Slope (%)	N/A	N/A	Clear Space to XWalk (in)	N/A
N/A	Any Obstructions?	N/A	N/A	Storm Grate/Utility Hazard?	N/A
	Obstruction Type			Storm Grate/Utility Type	
		N/A			N/A
			Yes	Surface Condition? (G/P)	Good

Possible Solutions:

Remove & Replace Entire Ramp.

Total Cost: \$ 1850.00
