# Access Compliance Report

## Public Rights-of-Way

### (Curb Ramps)

Intersection ID: 21789	Main Street: THORNCLIFF_DR	Cross Street: WOODSTOCK_DR	Location: E
ADA ID: C4AE6ACF7E61	Ramp Type: PerpDiag	Initial Pass/Fail: Fail	Overall Compliance: No
			Severity Score: 46.25

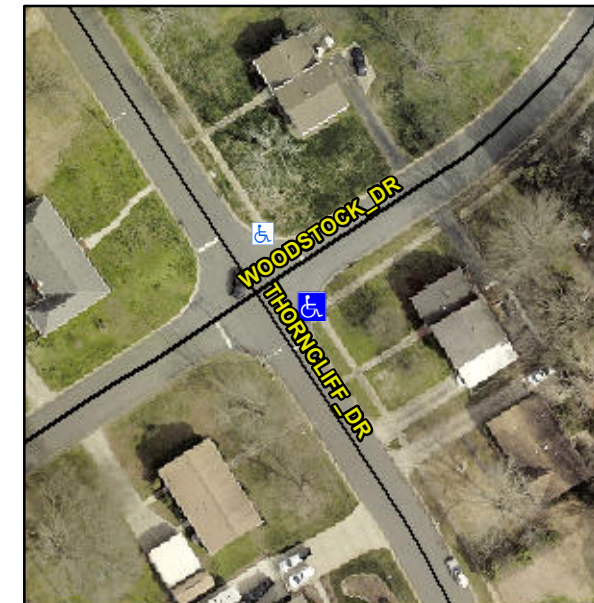
Compliance	Description	Data	Compliance	Description	Data
N/A	Ramp Length (in)	64.0	No	Ramp Slope (%)	15.3
No	Ramp Width (in)	43.0	No	Ramp XSlope (%)	5.7
N/A	Flare Type LT	N/A	N/A	Flare Type RT	N/A
N/A	Flare Slope LT (%)	N/A	N/A	Flare Slope RT (%)	N/A
N/A	Flare Traversable LT?	N/A	N/A	Flare Traversable RT?	N/A
N/A	Landing Length (in)	N/A	N/A	DWS Provided?	N/A
N/A	Landing Width (in)	N/A	N/A	DWS Contrast?	N/A
N/A	Landing Slope (%)	N/A	N/A	DWS Length (in)	N/A
N/A	Landing X Slope (%)	N/A	N/A	DWS Full Width?	N/A
N/A	Landing Curb? (Y/N)	N/A	N/A	DWS Offset (in)	N/A
N/A	Shared Landing?	N/A			
N/A	Gutter Ponding?	N/A	N/A	Gutter Slope (%)	N/A
N/A	Gutter Lip Ht (in)	N/A	N/A	Gutter X Slope (%)	N/A
N/A	Painted X Walk1?	No	N/A	Painted X Walk2?	No
	X Walk 1 Direction	To NW		X Walk 2 Direction	To SW
N/A	X Walk 1 Width (in)	N/A	N/A	X Walk 2 Width (in)	N/A
	X Walk 1 Slope (%)	6.9		X Walk 2 Slope (%)	5.3
	X Walk 1 X Slope (%)	1.3		X Walk 2 X Slope (%)	5.8

N/A	Ramp inside XWalk1?	N/A	N/A	Ramp inside XWalk2?	N/A
	Road Slope (%)	3.1	N/A	Clear Space?	N/A
	Road X Slope (%)	8.3	N/A	Clear Space to XWalk (in)	N/A
N/A	Any Obstructions?	N/A	N/A	Storm Grate/Utility Hazard?	N/A
	Obstruction Type			Storm Grate/Utility Type	
		N/A			N/A
			Yes	Surface Condition? (G/P)	Good

**Remove & Replace Curb Ramp With Two New Directional Ramps or Equivalent.**

**Not Found, R304.5.1, R304.2.2, R304.5.3**
