# Access Compliance Report

## Public Rights-of-Way

| Intersection ID: 53494 | Main Street: PROVIDENCE_COUNTRY_CLUB_DR | Cross Street: HONEYMEADE CIR | Location: SE |
| ADA ID: C4BD1E0F1E29 | Ramp Type: Directional | Initial Pass/Fail: Fail | Overall Compliance: No |

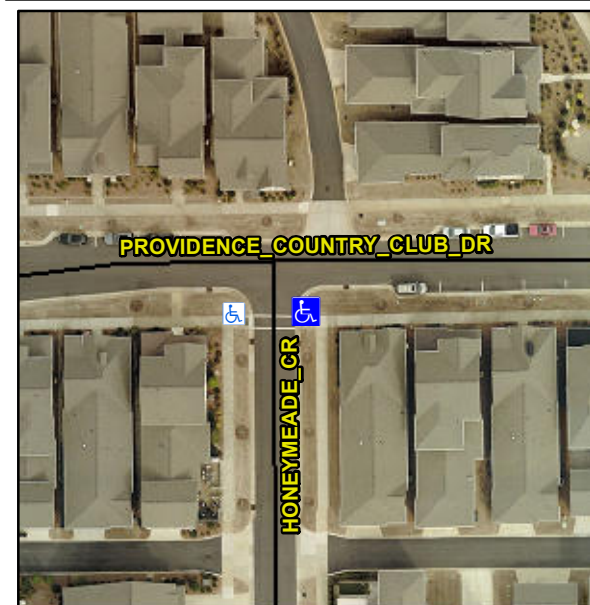
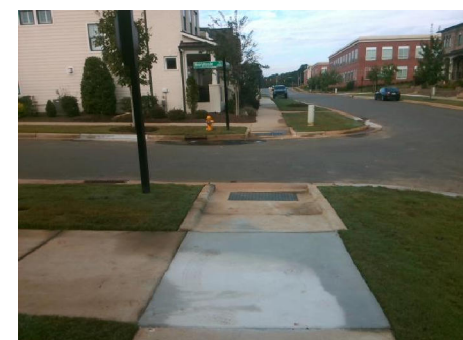
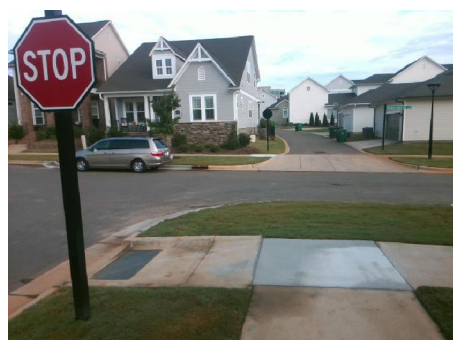
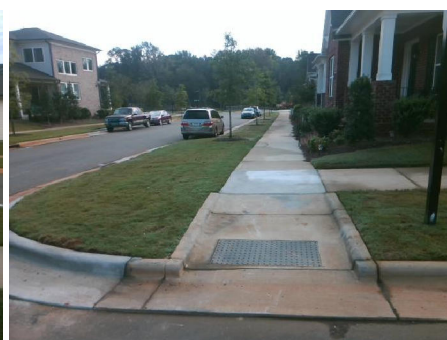
| Severity Score: 13.75 | | | |

**R304.2.2, R304.5.3**

| Compliance | Description | Data | Compliance | Description | Data |
|---|---|---|---|---|---|
| No | Ramp Slope (%) | 10.1 | N/A | Grade Break XSlope (%) | 0.0 |
| No | Ramp XSlope (%) | 2.6 | | | |

**Remove & Replace Entire Ramp.**

Total Cost: \$ **1600.00**
