Access Compliance Report Public Rights-of-Way (Curb Ramps)

Intersection ID: 23240 Main Street: SOUTH COMMERCE BV **Cross Street: WESTINGHOUSE BV** Location: **ADA ID: C4DFB3011EEB** Ramp Type: PerpDiag Initial Pass/Fail: Fail **Overall Compliance: No** Severity Score: 21.25

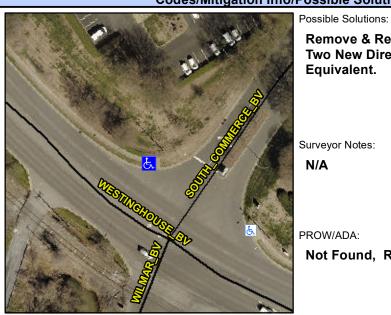
Field Measurements/Component Compnance						
	Comp	Compliance Description		Compliance Description		Data
	N/A	Ramp Length (in)	113.0	No	Ramp Slope (%)	9.6
	No	Ramp Width (in)	45.0	Yes	Ramp XSlope (%)	1.8
	N/A	Flare Type LT	N/A	N/A	Flare Type RT	N/A
	N/A	Flare Slope LT (%)	N/A	N/A	Flare Slope RT (%)	N/A
	N/A	Flare Traversable LT?	N/A	N/A	Flare Traversable RT?	N/A
	N/A	Landing Length (in)	N/A	N/A	DWS Provided?	N/A
	N/A	Landing Width (in)	N/A	N/A	DWS Contrast?	N/A
	N/A	Landing Slope (%)	N/A	N/A	DWS Length (in)	N/A
	N/A	Landing X Slope (%)	N/A	N/A	DWS Full Width?	N/A
	N/A	Landing Curb? (Y/N)	N/A	N/A	DWS Offset (in)	N/A
	N/A	Shared Landing?	N/A			
	N/A	Gutter Ponding?	N/A	N/A	Gutter Slope (%)	N/A
	N/A	Gutter Lip Ht (in)	N/A	N/A	Gutter X Slope (%)	N/A
	N/A	Painted X Walk1?	No	N/A	Painted X Walk2?	No
		X Walk 1 Direction	To SW		X Walk 2 Direction	To SE
	N/A	X Walk 1 Width (in)	N/A	N/A	X Walk 2 Width (in)	N/A
		X Walk 1 Slope (%)	2.8		X Walk 2 Slope (%)	0.9

X Walk 1 X Slope (%)	1.2		X Walk 2 X Slope (%)	3.7
	N/A	Ramp inside XWalk1?	N/A	N/A	Ramp inside XWalk2?	N/A
		Road Slope (%)	0.8	N/A	Clear Space?	N/A
		Road X Slope (%)	4.1	N/A	Clear Space to XWalk (in)	N/A
	N/A	Any Obstructions?	N/A	N/A	Storm Grate/Utility Hazard?	N/A
		Obstruction Type			Storm Grate/Utility Type	
			N/A			N/A
				Yes	Surface Condition? (G/P)	Good

WESTINGHOUSE BV None **SOUTH COMMERCE BV** StopSign Remove & Replace Curb Ramp With Two New Directional Ramps or Equivalent.

N/A PROW/ADA: Not Found, R304.5.1, R304.2.2 Total Cost: 3200.00
