Access Compliance Report

Public Rights-of-Way

(Curb Ramps)

Intersection ID: 20694	Main Street: LONG_MEADOW_RD	Cross Street: STOKES_AV	Location: NE
ADA ID: C4E3F65648F6	Ramp Type: PerpDiag	Initial Pass/Fail: Fail	Overall Compliance: No
Codes/Mitigation Info/Possible Solution			Severity Score: 22.5
			Field Measurements/Component Compliance

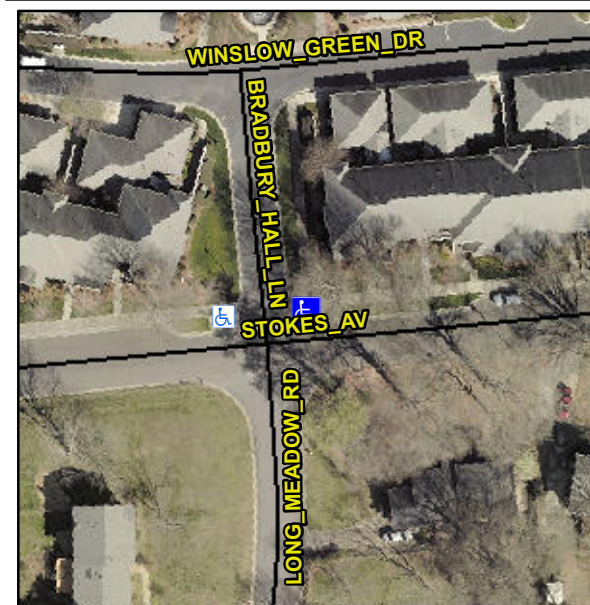
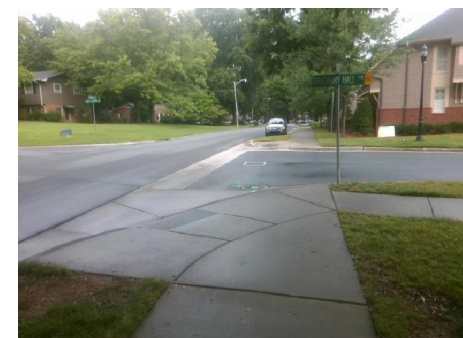
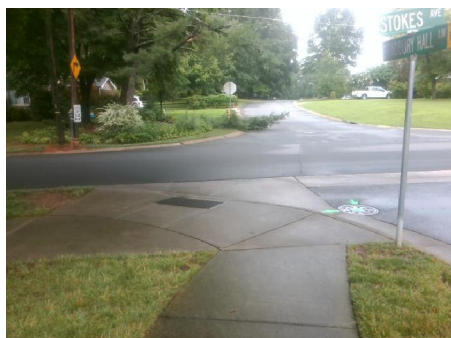
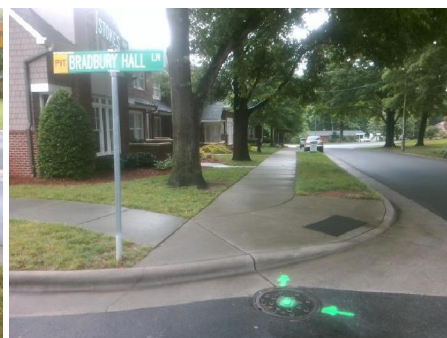
Not Found, R304.5.1, R304.2.2, R304.5.3

Compliance	Description	Data	Compliance	Description	Data
N/A	Ramp Length (in)	77.0	No	Ramp Slope (%)	8.6
No	Ramp Width (in)	36.0	No	Ramp XSlope (%)	3.9
N/A	Flare Type LT	N/A	N/A	Flare Type RT	N/A
N/A	Flare Slope LT (%)	N/A	N/A	Flare Slope RT (%)	N/A
N/A	Flare Traversable LT?	N/A	N/A	Flare Traversable RT?	N/A
N/A	Landing Length (in)	N/A	N/A	DWS Provided?	N/A
N/A	Landing Width (in)	N/A	N/A	DWS Contrast?	N/A
N/A	Landing Slope (%)	N/A	N/A	DWS Length (in)	N/A
N/A	Landing X Slope (%)	N/A	N/A	DWS Full Width?	N/A
N/A	Landing Curb? (Y/N)	N/A	N/A	DWS Offset (in)	N/A
N/A	Shared Landing?	N/A			
N/A	Gutter Ponding?	N/A	N/A	Gutter Slope (%)	N/A
N/A	Gutter Lip Ht (in)	N/A	N/A	Gutter X Slope (%)	N/A
N/A	Painted X Walk1?	No	N/A	Painted X Walk2?	No
	X Walk 1 Direction	To W		X Walk 2 Direction	To S
N/A	X Walk 1 Width (in)	N/A	N/A	X Walk 2 Width (in)	N/A
	X Walk 1 Slope (%)	2.4		X Walk 2 Slope (%)	4.3
	X Walk 1 X Slope (%)	1.2		X Walk 2 X Slope (%)	1.6

N/A	Ramp inside XWalk1?	N/A	N/A	Ramp inside XWalk2?	N/A
	Road Slope (%)	2.5	N/A	Clear Space?	N/A
	Road X Slope (%)	0.4	N/A	Clear Space to XWalk (in)	N/A
N/A	Any Obstructions?	N/A	N/A	Storm Grate/Utility Hazard?	N/A
	Obstruction Type			Storm Grate/Utility Type	
		N/A			N/A
			Yes	Surface Condition? (G/P)	Good

Remove & Replace Curb Ramp With Two New Directional Ramps or Equivalent.
