Access Compliance Report Public Rights-of-Way (Curb Ramps)

Main Street: WYALONG_DR Intersection ID: 47611 Cross Street: MINTWORTH_AV Location: NW **Overall Compliance: No Severity Score:** ADA ID: C500A573C380 Ramp Type: Perp Initial Pass/Fail: Fail 12.5

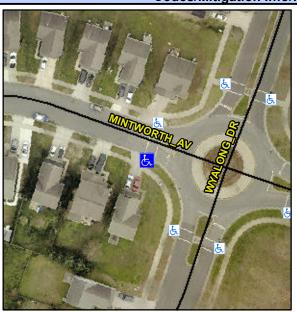
Field Measurements/Component Compliance							
Comp	liance Description	Data	Comp	liance	Description	Data	
N/A	Ramp Length (in)	106.0	No	Ramp	Slope (%)	10.8	
Yes	Ramp Width (in)	56.0	Yes	Ramp	XSlope (%)	0.6	
N/A	Flare Type LT	N/A	N/A	Flare	Type RT	N/A	
N/A	Flare Slope LT (%)	N/A	N/A	Flare	Slope RT (%)	N/A	
N/A	Flare Traversable LT?	N/A	N/A	Flare	Traversable RT?	N/A	
N/A	Landing Length (in)	N/A	N/A	DWS	Provided?	N/A	
N/A	Landing Width (in)	N/A	N/A	DWS	Contrast?	N/A	
N/A	Landing Slope (%)	N/A	N/A	DWS	Length (in)	N/A	
N/A	Landing X Slope (%)	N/A	N/A	DWS	Full Width?	N/A	
N/A	Landing Curb? (Y/N)	N/A	N/A	DWS	Offset (in)	N/A	
N/A	Shared Landing?	N/A					
N/A	Gutter Ponding?	N/A	N/A	Gutte	r Slope (%)	N/A	
N/A	Gutter Lip Ht (in)	N/A	N/A	Gutte	r X Slope (%)	N/A	
N/A	Painted X Walk1?	Yes	N/A	Paint	ed X Walk2?	N/A	
	X Walk 1 Direction	To NE		X Wa	lk 2 Direction	N/A	
N/A	X Walk 1 Width (in)	121.0	N/A	X Wa	lk 2 Width (in)	N/A

X Walk 1 Slope (%)	5.3		X Wa	lk 2 Slope (%)	N/A	
	X Walk 1 X Slope (%)	5.1		X Wa	lk 2 X Slope (%)	N/A	
N/A	Ramp inside XWalk1?	Yes	N/A	Ram	inside XWalk2?	N/A	
	Road Slope (%)	N/A	N/A	Clear	Space?	N/A	
	Road X Slope (%)	N/A	N/A	Clear	Space to XWalk (in)	N/A	
N/A	Any Obstructions?	N/A	N/A	Storn	n Grate/Utility Hazard?	N/A	
	Obstruction Type			Storn	n Grate/Utility Type		
		N/A				N/A	
			Yes	Surfa	ce Condition? (G/P)	Good	
	72-101-101-101-101

ossible solution			
Possible Solutions:	C		
Remove & Replace Entire Ramp.			
	Ye		
	N/		
Surveyor Notes:	N/		
N/A	N/		
	N/		
	N/		
	N/		
PROW/ADA:	N/		
Not Found, R304.2.2	N/

1850.00
