Access Compliance Report

Public Rights-of-Way

(Curb Ramps)

| Intersection ID: 44467 | Main Street: BUCKHORN_ST | Cross Street: ROSBERG_LN | Location: NE |

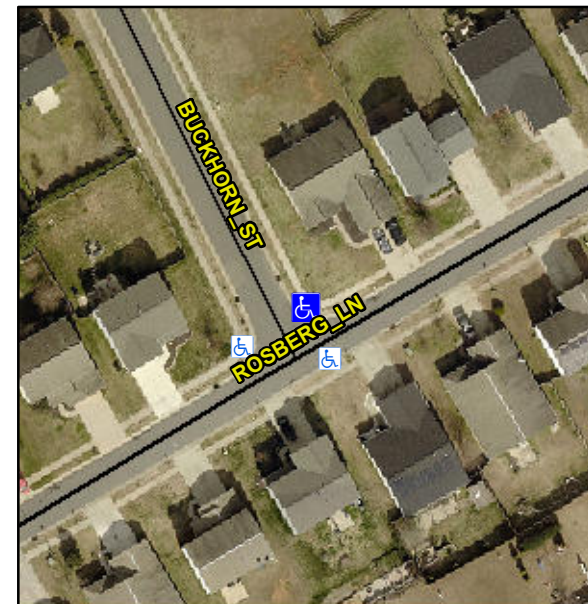
| ADA ID: C501BDB1877F | Ramp Type: PerpDiag | Initial Pass/Fail: Fail | Overall Compliance: No |
| Codes/Mitigation Info/Possible Solution | | | Severity Score: 10 |

Not Found, R304.5.1, R304.5.3

| Compliance | Description | Data | Compliance | Description | Data |
|---|---|---|---|---|---|
| N/A | Ramp Length (in) | 47.5 | Yes | Ramp Slope (%) | 6.6 |
| No | Ramp Width (in) | 36.0 | No | Ramp XSlope (%) | 2.9 |

Remove & Replace Curb Ramp With Two New Directional Ramps or Equivalent.

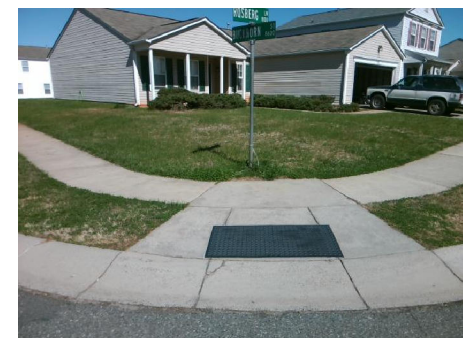
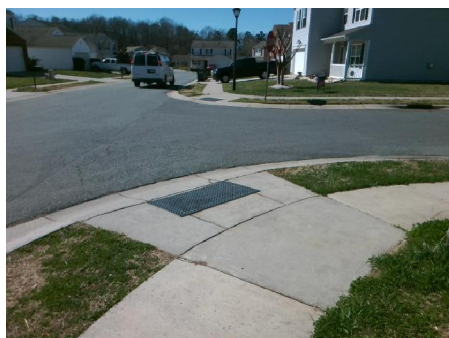
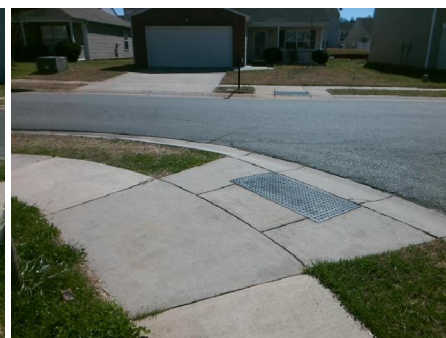
| Compliance | Description | Data | Compliance | Description | Data |
|---|---|---|---|---|---|
| | | | Yes | Surface Condition? (G/P) | Good |
