# Access Compliance Report

## Public Rights-of-Way

### (Curb Ramps)

Intersection ID: 8685	Main Street: BEATTIES_FORD_RD	Cross Street: ST_JOHN_ST	Location: SE
ADA ID: C50D9A34AF07	Ramp Type: Perp	Initial Pass/Fail: Fail	Overall Compliance: No
Severity Score: 33.75			
Codes/Mitigation Info/Possible Solution		Field Measurements/Component Compliance

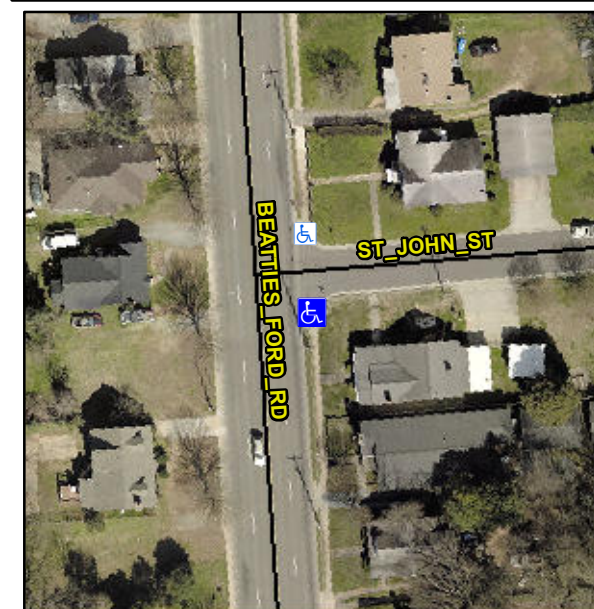
**Not Found, R304.5.1, R304.2.2, R304.5.3**

Compliance	Description	Data	Compliance	Description	Data
N/A	Ramp Length (in)	63.0	No	Ramp Slope (%)	8.6
No	Ramp Width (in)	46.5	No	Ramp XSlope (%)	6.7
N/A	Flare Type LT	N/A	N/A	Flare Type RT	N/A
N/A	Flare Slope LT (%)	N/A	N/A	Flare Slope RT (%)	N/A
N/A	Flare Traversable LT?	N/A	N/A	Flare Traversable RT?	N/A
N/A	Landing Length (in)	N/A	N/A	DWS Provided?	N/A
N/A	Landing Width (in)	N/A	N/A	DWS Contrast?	N/A
N/A	Landing Slope (%)	N/A	N/A	DWS Length (in)	N/A
N/A	Landing X Slope (%)	N/A	N/A	DWS Full Width?	N/A
N/A	Landing Curb? (Y/N)	N/A	N/A	DWS Offset (in)	N/A
N/A	Shared Landing?	N/A			
N/A	Gutter Ponding?	N/A	N/A	Gutter Slope (%)	N/A
N/A	Gutter Lip Ht (in)	N/A	N/A	Gutter X Slope (%)	N/A
N/A	Painted X Walk1?	No	N/A	Painted X Walk2?	N/A
	X Walk 1 Direction	To N		X Walk 2 Direction	N/A
N/A	X Walk 1 Width (in)	N/A	N/A	X Walk 2 Width (in)	N/A
	X Walk 1 Slope (%)	3.3		X Walk 2 Slope (%)	N/A
	X Walk 1 X Slope (%)	7.1		X Walk 2 X Slope (%)	N/A

N/A	Ramp inside XWalk1?	N/A	N/A	Ramp inside XWalk2?	N/A
	Road Slope (%)	N/A	N/A	Clear Space?	N/A
	Road X Slope (%)	N/A	N/A	Clear Space to XWalk (in)	N/A
N/A	Any Obstructions?	N/A	N/A	Storm Grate/Utility Hazard?	N/A
	Obstruction Type			Storm Grate/Utility Type	
		N/A			N/A
			Yes	Surface Condition? (G/P)	Good

**Remove & Replace Entire Ramp.**

Total Cost: \$ 1850.00
