Access Compliance Report

Public Rights-of-Way

(Curb Ramps)

Intersection ID: 27717	Main Street: HEADFORD_RD	Cross Street: LEINSTER_DR	Location: NE
ADA ID: C52333AE5A29	Ramp Type: BlendTrans1	Initial Pass/Fail: Fail	Overall Compliance: No
		Severity Score: 47.5

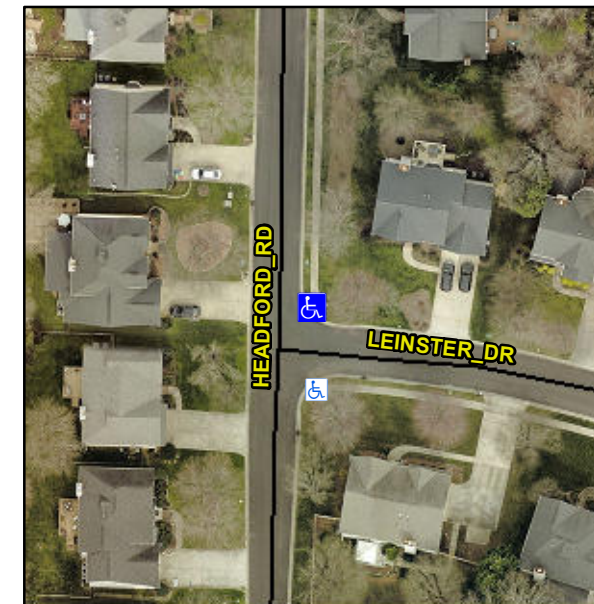
Not Found, R304.5.1, R304.5.3

Compliance	Description	Data	Compliance	Description	Data
N/A	Ramp Length (in)	96.0	Yes	BlendTrans Slope (%)	4.6
No	Ramp Width (in)	25.0	No	BlendTrans XSlope (%)	5.3
N/A	Flare Type LT	N/A	N/A	Flare Type RT	N/A
N/A	Flare Slope LT (%)	N/A	N/A	Flare Slope RT (%)	N/A
N/A	Flare Traversable LT?	N/A	N/A	Flare Traversable RT?	N/A
N/A	Landing Length (in)	N/A	N/A	DWS Provided?	N/A
N/A	Landing Width (in)	N/A	N/A	DWS Contrast?	N/A
N/A	Landing Slope (%)	N/A	N/A	DWS Length (in)	N/A
N/A	Landing X Slope (%)	N/A	N/A	DWS Full Width?	N/A
N/A	Landing Curb? (Y/N)	N/A	N/A	DWS Offset (in)	N/A
N/A	Shared Landing?	N/A			
N/A	Gutter Ponding?	N/A	N/A	Gutter Slope (%)	N/A
N/A	Gutter Lip Ht (in)	N/A	N/A	Gutter X Slope (%)	N/A
N/A	Painted X Walk1?	No	N/A	Painted X Walk2?	No
	X Walk 1 Direction	To W		X Walk 2 Direction	To S
	X Walk 1 Width (in)	N/A		X Walk 2 Width (in)	N/A
	X Walk 1 Slope (%)	1.4		X Walk 2 Slope (%)	3.1
	X Walk 1 X Slope (%)	5.0		X Walk 2 X Slope (%)	1.9

N/A	Ramp inside XWalk1?	N/A	N/A	Ramp inside XWalk2?	N/A
	Road Slope (%)	5.7		Clear Space?	N/A
	Road X Slope (%)	2.2	N/A	Clear Space to XWalk (in)	N/A
N/A	Any Obstructions?	N/A	N/A	Storm Grate/Utility Hazard?	N/A
	Obstruction Type			Storm Grate/Utility Type	
		N/A			N/A
			Yes	Surface Condition? (G/P)	Good
			No	Curb Slope (%)	13.7

Remove & Replace Curb Ramp With Two New Directional Ramps or Equivalent.
