# Access Compliance Report

## Public Rights-of-Way

### (Curb Ramps)

| Intersection ID: 22069 | Main Street: CARMEL_RD | Cross Street: KNAPDALE_LN | Location: W |

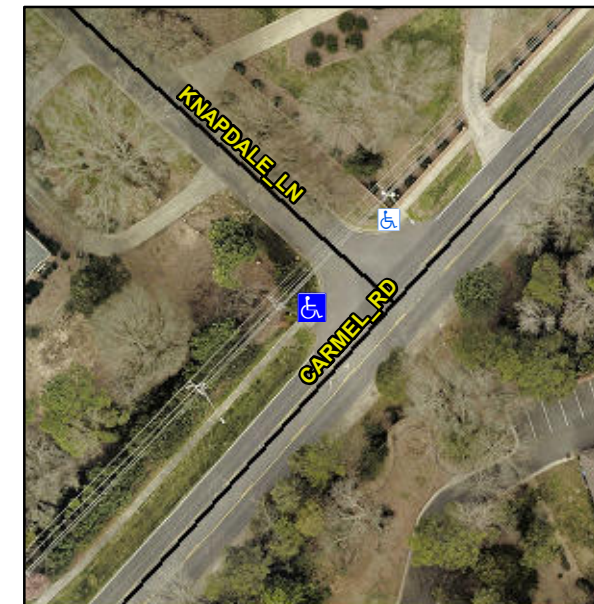
**ASP LIP 1.0", CURB LIP 1.5"**

**R304.2.2, R304.5.3**

| Compliance | Description | Data | Compliance | Description | Data |
|---|---|---|---|---|---|
| No | Ramp Slope (%) | 14.2 | N/A | Grade Break XSlope (%) | 0.0 |
| No | Ramp XSlope (%) | 4.2 | | | |

**Remove & Replace Entire Ramp.**
