# Access Compliance Report

## Public Rights-of-Way

### (Curb Ramps)

Intersection ID: 23277	Main Street: S_TRYON_ST	Cross Street: CAROWINDS_BV	Location: E
ADA ID: C53011D98C18	Ramp Type: Perp	Initial Pass/Fail: Fail	Overall Compliance: No
Severity Score: 22.5			
Codes/Mitigation Info/Possible Solution		Field Measurements/Component Compliance

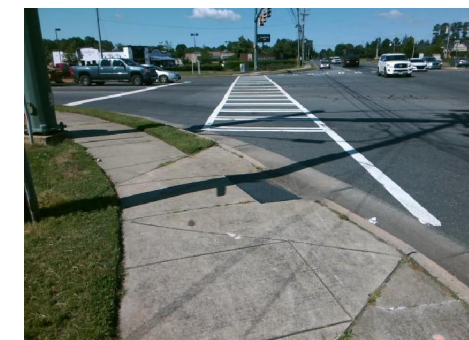
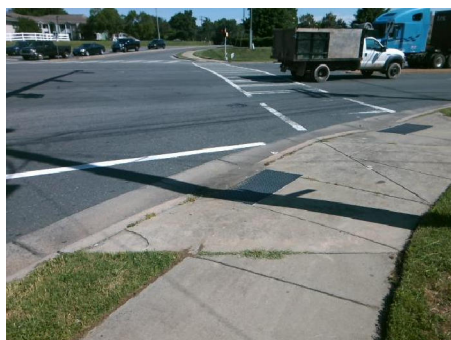
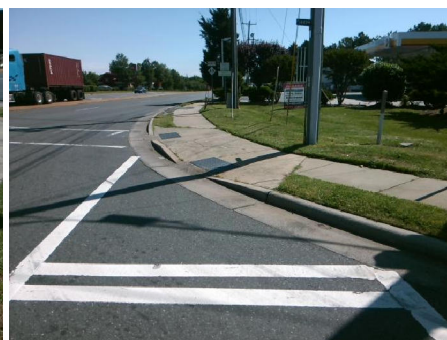
Compliance	Description	Data	Compliance	Description	Data
N/A	Ramp Length (in)	54.0	No	Ramp Slope (%)	8.5
No	Ramp Width (in)	46.0	No	Ramp XSlope (%)	2.1
N/A	Flare Type LT	N/A	N/A	Flare Type RT	N/A
N/A	Flare Slope LT (%)	N/A	N/A	Flare Slope RT (%)	N/A
N/A	Flare Traversable LT?	N/A	N/A	Flare Traversable RT?	N/A
N/A	Landing Length (in)	N/A	N/A	DWS Provided?	N/A
N/A	Landing Width (in)	N/A	N/A	DWS Contrast?	N/A
N/A	Landing Slope (%)	N/A	N/A	DWS Length (in)	N/A
N/A	Landing X Slope (%)	N/A	N/A	DWS Full Width?	N/A
N/A	Landing Curb? (Y/N)	N/A	N/A	DWS Offset (in)	N/A
N/A	Shared Landing?	N/A			
N/A	Gutter Ponding?	N/A	N/A	Gutter Slope (%)	N/A
N/A	Gutter Lip Ht (in)	N/A	N/A	Gutter X Slope (%)	N/A
N/A	Painted X Walk1?	Yes	N/A	Painted X Walk2?	N/A
	X Walk 1 Direction	To SW		X Walk 2 Direction	N/A
N/A	X Walk 1 Width (in)	115.0	N/A	X Walk 2 Width (in)	N/A
	X Walk 1 Slope (%)	0.1		X Walk 2 Slope (%)	N/A
	X Walk 1 X Slope (%)	0.5		X Walk 2 X Slope (%)	N/A

N/A	Ramp inside XWalk1?	Yes	N/A	Ramp inside XWalk2?	N/A
	Road Slope (%)	N/A	N/A	Clear Space?	N/A
	Road X Slope (%)	N/A	N/A	Clear Space to XWalk (in)	N/A
N/A	Any Obstructions?	N/A	N/A	Storm Grate/Utility Hazard?	N/A
	Obstruction Type			Storm Grate/Utility Type	
		N/A			N/A
			Yes	Surface Condition? (G/P)	Good

**Remove & Replace Entire Ramp.**
