Access Compliance Report Public Rights-of-Way (Curb Ramps)

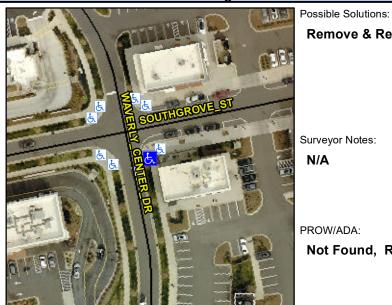
Intersection ID: 53416Main Street:WAVERLY_CENTER_DRCross Street:SOUTHGROVE_STLocation:SEADA ID: C531D2904382Ramp Type:PerpInitial Pass/Fail:FailOverall Compliance:NoSeverity Score:10

Field Measurements/Component Compliance								
Comp	Compliance Description		ata Compliance Description		Data			
N/A	Ramp Length (in)	72.0	Yes	Ramp Slope (%)	7.0			
No	Ramp Width (in)	44.0	No	Ramp XSlope (%)	2.5			
N/A	Flare Type LT	N/A	N/A	Flare Type RT	N/A			
N/A	Flare Slope LT (%)	N/A	N/A	Flare Slope RT (%)	N/A			
N/A	Flare Traversable LT?	N/A	N/A	Flare Traversable RT?	N/A			
N/A	Landing Length (in)	N/A	N/A	DWS Provided?	N/A			
N/A	Landing Width (in)	N/A	N/A	DWS Contrast?	N/A			
N/A	Landing Slope (%)	N/A	N/A	DWS Length (in)	N/A			
N/A	Landing X Slope (%)	N/A	N/A	DWS Full Width?	N/A			
N/A	Landing Curb? (Y/N)	N/A	N/A	DWS Offset (in)	N/A			
N/A	Shared Landing?	N/A						
N/A	Gutter Ponding?	N/A	N/A	Gutter Slope (%)	N/A			
N/A	Gutter Lip Ht (in)	N/A	N/A	Gutter X Slope (%)	N/A			
N/A	Painted X Walk1?	No	N/A	Painted X Walk2?	N/A			
	X Walk 1 Direction	To W		X Walk 2 Direction	N/A			
N/A	X Walk 1 Width (in)	N/A	N/A	X Walk 2 Width (in)	N/A

X Walk 1 Slope (%)	0.9		X Walk 2 Slope (%)	N/A			
	X Walk 1 X Slope (%)	1.3		X Walk 2 X Slope (%)	N/A			
N/A	Ramp inside XWalk1?	N/A	N/A	Ramp inside XWalk2?	N/A			
	Road Slope (%)	N/A	N/A	Clear Space?	N/A			
	Road X Slope (%)	N/A	N/A	Clear Space to XWalk (in)	N/A			
N/A	Any Obstructions?	N/A	N/A	Storm Grate/Utility Hazard?	N/A			
	Obstruction Type			Storm Grate/Utility Type				
		N/A			N/A			
			Yes	Surface Condition? (G/P)	Good

Remove & Replace Entire Ramp.				
	·	N		
-		N		
3		N		
		N		
ì		N		
	Surveyor Notes:	N		
1	N/A	N		
9		N		
		N		
,		N		
	PROW/ADA:	N		
4	Not Found, R304.5.1, R304.5.3	N		
	,,,,	N		
		N		
		N
