# Access Compliance Report

## Public Rights-of-Way

### (Curb Ramps)

Intersection ID: 27844	Main Street: BRIARWICK_LN	Cross Street: OTTERDALE_CT	Location: NW
ADA ID: C5323C24D14A	Ramp Type: PerpDiag	Initial Pass/Fail: Fail	Overall Compliance: No
		Severity Score: 12.5

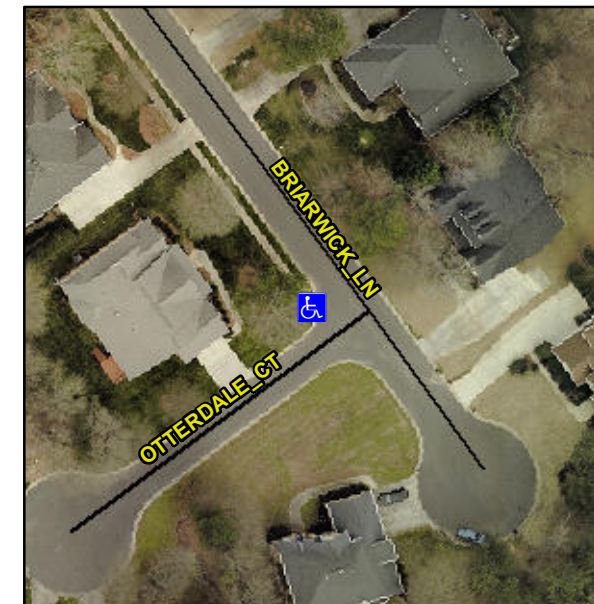
**Not Found, R304.2.2**

Compliance	Description	Data	Compliance	Description	Data
N/A	Ramp Length (in)	97.0	No	Ramp Slope (%)	8.9
Yes	Ramp Width (in)	48.0	Yes	Ramp XSlope (%)	0.4
N/A	Flare Type LT	N/A	N/A	Flare Type RT	N/A
N/A	Flare Slope LT (%)	N/A	N/A	Flare Slope RT (%)	N/A
N/A	Flare Traversable LT?	N/A	N/A	Flare Traversable RT?	N/A
N/A	Landing Length (in)	N/A	N/A	DWS Provided?	N/A
N/A	Landing Width (in)	N/A	N/A	DWS Contrast?	N/A
N/A	Landing Slope (%)	N/A	N/A	DWS Length (in)	N/A
N/A	Landing X Slope (%)	N/A	N/A	DWS Full Width?	N/A
N/A	Landing Curb? (Y/N)	N/A	N/A	DWS Offset (in)	N/A
N/A	Shared Landing?	N/A			
N/A	Gutter Ponding?	N/A	N/A	Gutter Slope (%)	N/A
N/A	Gutter Lip Ht (in)	N/A	N/A	Gutter X Slope (%)	N/A
N/A	Painted X Walk1?	No	N/A	Painted X Walk2?	No
	X Walk 1 Direction	To SW		X Walk 2 Direction	To E
N/A	X Walk 1 Width (in)	N/A	N/A	X Walk 2 Width (in)	N/A
	X Walk 1 Slope (%)	2.3		X Walk 2 Slope (%)	1.3
	X Walk 1 X Slope (%)	2.3		X Walk 2 X Slope (%)	2.3

N/A	Ramp inside XWalk1?	N/A	N/A	Ramp inside XWalk2?	N/A
	Road Slope (%)	0.9	N/A	Clear Space?	N/A
	Road X Slope (%)	3.3	N/A	Clear Space to XWalk (in)	N/A
N/A	Any Obstructions?	N/A	N/A	Storm Grate/Utility Hazard?	N/A
	Obstruction Type			Storm Grate/Utility Type	
		N/A			N/A
		Yes		Surface Condition? (G/P)	Good

**Remove & Replace Curb Ramp With Two New Directional Ramps or Equivalent.**

Total Cost: \$ 3200.00
