Access Compliance Report

Public Rights-of-Way (Curb Ramps)

Intersection ID: 21450	Main Street: STERNCREST_PL	Cross Street: WOODSTREAM_DR	Location: SW
ADA ID: C5540DBDD7D1	Ramp Type: Directional1	Initial Pass/Fail: Fail	Overall Compliance: No
		Severity Score: 10

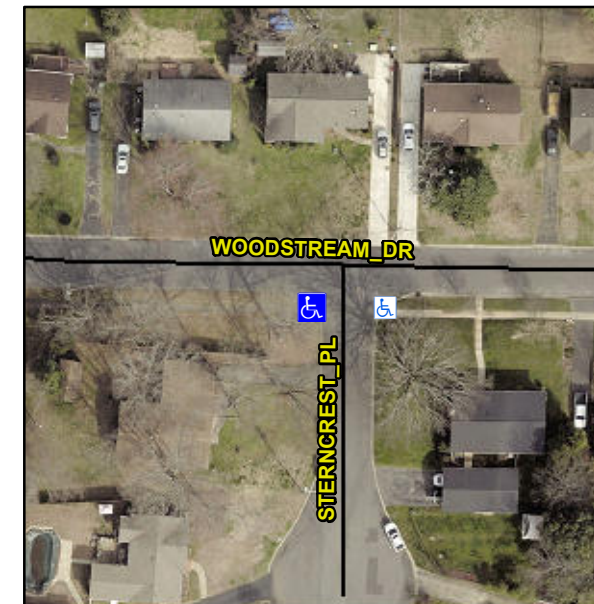
R304.5.1, R304.5.3

Compliance	Description	Data	Compliance	Description	Data
N/A	Ramp Length (in)	24.0	N/A	Grade Break?	N/A
No	Ramp Width (in)	47.5	N/A	Grade Break Slope (%)	0.0
Yes	Ramp Slope (%)	1.0	N/A	Grade Break XSlope (%)	0.0
No	Ramp XSlope (%)	5.0			
N/A	Flare Type LT	N/A	N/A	Flare Type RT	N/A
N/A	Flare Slope LT (%)	N/A	N/A	Flare Slope RT (%)	0.0
N/A	Flare Traversable LT?	N/A	N/A	Flare Traversable RT?	N/A
N/A	Landing Length (in)	0.0	N/A	DWS Provided?	N/A
N/A	Landing Width (in)	0.0	N/A	DWS Contrast?	N/A
N/A	Landing Slope (%)	0.0	N/A	DWS Length (in)	N/A
N/A	Landing X Slope (%)	0.0	N/A	DWS Full Width?	N/A
N/A	Landing Curb? (Y/N)	N/A	N/A	DWS Offset LT (in)	N/A
N/A	Shared Landing?	N/A	N/A	DWS Offset RT (in)	N/A
N/A	Gutter Ponding?	0.0	N/A	Gutter Slope (%)	N/A
N/A	Gutter Lip Ht (in)	0.0	N/A	Gutter X Slope (%)	N/A
N/A	Painted X Walk1?	No		Road Slope (%)	5.3
	X Walk 1 Direction	To NE		Road X Slope (%)	4.2
	X Walk 1 Width (in)	N/A		Clear Space?	N/A

X Walk 1 Slope (%)	5.3	N/A	Clear Space to XWalk (in)	N/A
	X Walk 1 X Slope (%)	4.2	N/A	Storm Grate/Utility Hazard?	N/A
N/A	Ramp inside XWalk1?	N/A		Storm Grate/Utility Type	
N/A	Any Obstructions?	N/A			N/A
	Obstruction Type		Yes	Surface Condition? (G/P)	Good
			N/A	Curb Slope (%)	3.3

Remove & Replace Entire Ramp.

\$ 1600.00
