Access Compliance Report

Public Rights-of-Way

(Curb Ramps)

Intersection ID: 3673	Main Street: KEENELAND_LN	Cross Street: DENALI_LN	Location:	SE
ADA ID: C554B63A6180	Ramp Type: Perp	Initial Pass/Fail: Fail	Overall Compliance: No	Severity Score: 30
Codes/Mitigation Info/Possible Solution		Field Measurements/Component Compliance

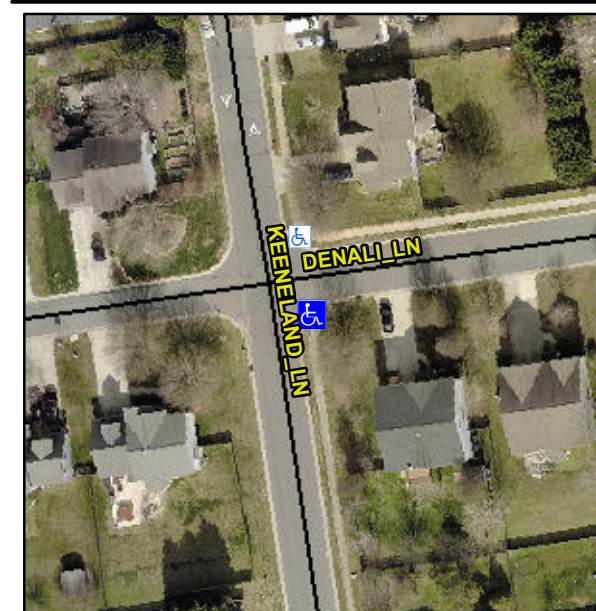
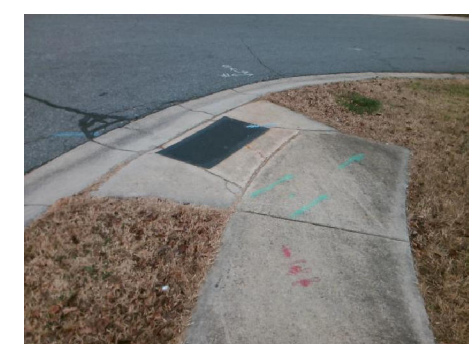
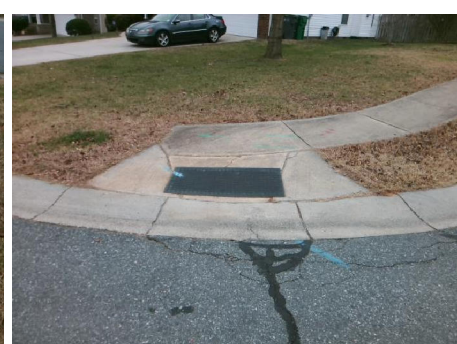
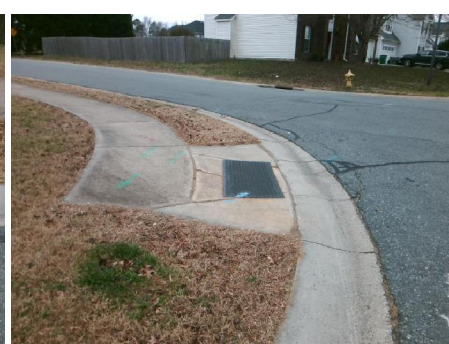
Not Found, R304.5.1, R304.5.3

Compliance	Description	Data	Compliance	Description	Data
N/A	Ramp Length (in)	42.5	Yes	Ramp Slope (%)	5.7
No	Ramp Width (in)	35.0	No	Ramp XSlope (%)	5.4
N/A	Flare Type LT	N/A	N/A	Flare Type RT	N/A
N/A	Flare Slope LT (%)	N/A	N/A	Flare Slope RT (%)	N/A
N/A	Flare Traversable LT?	N/A	N/A	Flare Traversable RT?	N/A
N/A	Landing Length (in)	N/A	N/A	DWS Provided?	N/A
N/A	Landing Width (in)	N/A	N/A	DWS Contrast?	N/A
N/A	Landing Slope (%)	N/A	N/A	DWS Length (in)	N/A
N/A	Landing X Slope (%)	N/A	N/A	DWS Full Width?	N/A
N/A	Landing Curb? (Y/N)	N/A	N/A	DWS Offset (in)	N/A
N/A	Shared Landing?	N/A			
N/A	Gutter Ponding?	N/A	N/A	Gutter Slope (%)	N/A
N/A	Gutter Lip Ht (in)	N/A	N/A	Gutter X Slope (%)	N/A
N/A	Painted X Walk1?	No	N/A	Painted X Walk2?	N/A
	X Walk 1 Direction	To N		X Walk 2 Direction	N/A
N/A	X Walk 1 Width (in)	N/A	N/A	X Walk 2 Width (in)	N/A
	X Walk 1 Slope (%)	0.9		X Walk 2 Slope (%)	N/A
	X Walk 1 X Slope (%)	5.8		X Walk 2 X Slope (%)	N/A

N/A	Ramp inside XWalk1?	N/A	N/A	Ramp inside XWalk2?	N/A
	Road Slope (%)	N/A	N/A	Clear Space?	N/A
	Road X Slope (%)	N/A	N/A	Clear Space to XWalk (in)	N/A
N/A	Any Obstructions?	N/A	N/A	Storm Grate/Utility Hazard?	N/A
	Obstruction Type			Storm Grate/Utility Type	
		N/A			N/A
			Yes	Surface Condition? (G/P)	Good

Remove & Replace Entire Ramp.
