# Access Compliance Report

## Public Rights-of-Way

### (Curb Ramps)

Intersection ID: 8391	Main Street: LASALLE_ST	Cross Street: MADRID_ST	Location: SE
ADA ID: C573810F1155	Ramp Type: PerpDiag	Initial Pass/Fail: Fail	Overall Compliance: No
			Severity Score: 46.25

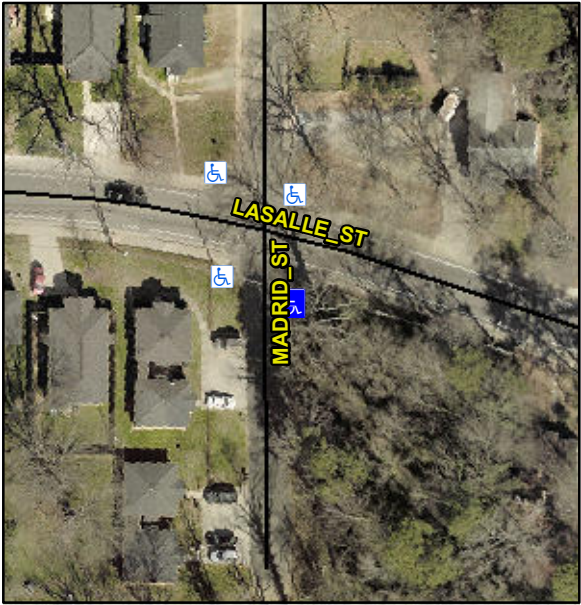
Possible Solutions:		<b>Compliance</b>	<b>Description</b>	<b>Data</b>
	<b>Remove &amp; Replace Curb Ramp With Two New Directional Ramps or Equivalent.</b>		<b>No</b>	Ramp Length (in)	<b>62.5</b>
			<b>No</b>	Ramp Width (in)	<b>39.0</b>
			<b>N/A</b>	Flare Type LT	<b>N/A</b>
			<b>N/A</b>	Flare Slope LT (%)	<b>N/A</b>
			<b>N/A</b>	Flare Traversable LT?	<b>N/A</b>
			<b>N/A</b>	Landing Length (in)	<b>N/A</b>
			<b>N/A</b>	Landing Width (in)	<b>N/A</b>
			<b>N/A</b>	Landing Slope (%)	<b>N/A</b>
			<b>N/A</b>	Landing X Slope (%)	<b>N/A</b>
<p>Surveyor Notes:</p> <p><b>N/A</b></p> <p>PROW/ADA:</p> <p><b>Not Found, R304.5.1, R304.2.2, R304.5.3</b></p>			<b>N/A</b>	Flare Type RT	<b>N/A</b>
			<b>N/A</b>	Flare Slope RT (%)	<b>N/A</b>
			<b>N/A</b>	Flare Traversable RT?	<b>N/A</b>
			<b>N/A</b>	DWS Provided?	<b>N/A</b>
			<b>N/A</b>	DWS Contrast?	<b>N/A</b>

<b>N/A</b>	DWS Length (in)	<b>N/A</b>
			<b>N/A</b>	DWS Full Width?	<b>N/A</b>
			<b>N/A</b>	DWS Offset (in)	<b>N/A</b>
			<b>N/A</b>	Gutter Ponding?	<b>N/A</b>
			<b>N/A</b>	Gutter Lip Ht (in)	<b>0.8</b>
<p>Total Cost:</p> <p><b>\$ 3200.00</b></p>			<b>No</b>	Painted X Walk1?	<b>No</b>
				X Walk 1 Direction	<b>To N</b>
			<b>N/A</b>	X Walk 1 Width (in)	<b>N/A</b>
				X Walk 1 Slope (%)	<b>1.7</b>
				X Walk 1 X Slope (%)	<b>3.1</b>
			<b>N/A</b>	Ramp inside XWalk1?	<b>N/A</b>
				Road Slope (%)	<b>6.9</b>
				Road X Slope (%)	<b>2.3</b>
			<b>N/A</b>	Any Obstructions?	<b>N/A</b>
				Obstruction Type	
			<b>N/A</b>	Storm Grate/Utility Hazard?	<b>N/A</b>
				Storm Grate/Utility Type	
			<b>N/A</b>		<b>N/A</b>
			<b>Yes</b>	Surface Condition? (G/P)	<b>Good</b>
