# Access Compliance Report

## Public Rights-of-Way

### (Curb Ramps)

Intersection ID: 54324	Main Street: BELMONT_MANSION_DR	Cross Street: ROCKY_HILL_CASTLE_DR	Location: NW
ADA ID: C576D3553029	Ramp Type: Perp	Initial Pass/Fail: Fail	Overall Compliance: No
Severity Score: 13.75			
Codes/Mitigation Info/Possible Solution		Field Measurements/Component Compliance

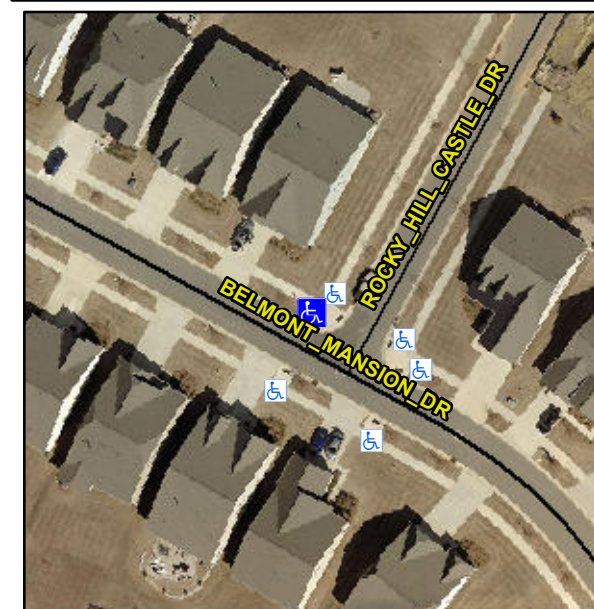
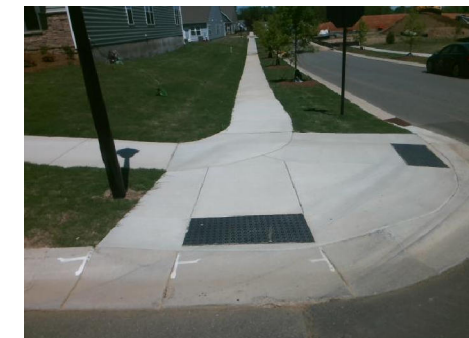
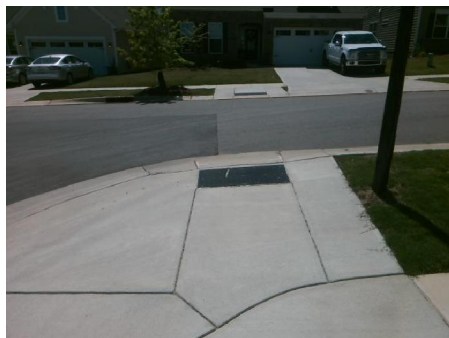
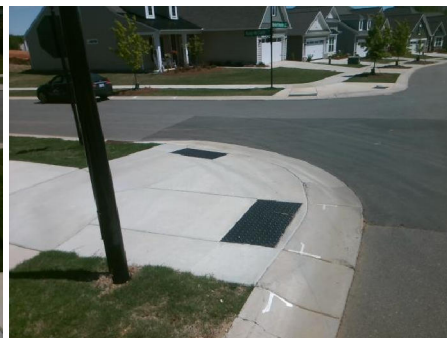
Compliance	Description	Data	Compliance	Description	Data
N/A	Ramp Length (in)	101.0	No	Ramp Slope (%)	9.3
Yes	Ramp Width (in)	48.0	Yes	Ramp XSlope (%)	4.1
N/A	Flare Type LT	N/A	N/A	Flare Type RT	N/A
N/A	Flare Slope LT (%)	N/A	N/A	Flare Slope RT (%)	N/A
N/A	Flare Traversable LT?	N/A	N/A	Flare Traversable RT?	N/A
N/A	Landing Length (in)	N/A	N/A	DWS Provided?	N/A
N/A	Landing Width (in)	N/A	N/A	DWS Contrast?	N/A
N/A	Landing Slope (%)	N/A	N/A	DWS Length (in)	N/A
N/A	Landing X Slope (%)	N/A	N/A	DWS Full Width?	N/A
N/A	Landing Curb? (Y/N)	N/A	N/A	DWS Offset (in)	N/A
N/A	Shared Landing?	N/A			
N/A	Gutter Ponding?	N/A	N/A	Gutter Slope (%)	N/A
N/A	Gutter Lip Ht (in)	1.0	N/A	Gutter X Slope (%)	N/A
N/A	Painted X Walk1?	No	N/A	Painted X Walk2?	N/A
	X Walk 1 Direction	To SW		X Walk 2 Direction	N/A
N/A	X Walk 1 Width (in)	N/A	N/A	X Walk 2 Width (in)	N/A
	X Walk 1 Slope (%)	5.6		X Walk 2 Slope (%)	N/A
	X Walk 1 X Slope (%)	4.9		X Walk 2 X Slope (%)	N/A

N/A	Ramp inside XWalk1?	N/A	N/A	Ramp inside XWalk2?	N/A
	Road Slope (%)	N/A	N/A	Clear Space?	N/A
	Road X Slope (%)	N/A	N/A	Clear Space to XWalk (in)	N/A
N/A	Any Obstructions?	N/A	N/A	Storm Grate/Utility Hazard?	N/A
	Obstruction Type			Storm Grate/Utility Type	
		N/A			N/A
			Yes	Surface Condition? (G/P)	Good

Possible Solutions:

**Remove & Replace Entire Ramp.**

**R304.2.2**

**\$ 1850.00**
