Access Compliance Report

Public Rights-of-Way

(Curb Ramps)

| Intersection ID: 26472 | Main Street: MANNINGTON_DR | Cross Street: MCKEE_FARM_LN | Location: SE |

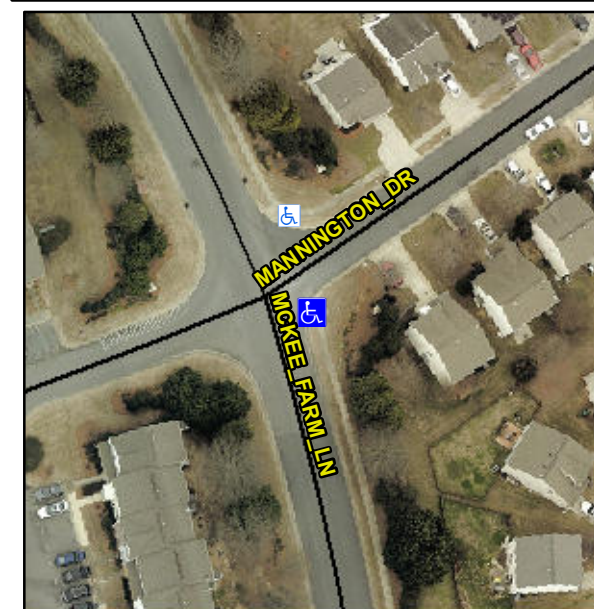
Not Found, R304.2.2-Perp, R304.3.2-Para, R304.5.3, R305

| Compliance | Description | Data | Compliance | Description | Data |
|---|---|---|---|---|---|
| Yes | Landing Length (in) | 50.0 | No | DWS Provided? | No |
| No | Landing Slope (%) | 7.6 | N/A | DWS Length (in) | N/A |
| No | Landing X Slope (%) | 3.1 | N/A | DWS Full Width? | No |

Remove & Replace Entire Ramp.
