## Access Compliance Report Public Rights-of-Way (Curb Ramps)

Intersection ID: 31083 Main Street: BROOKINGS\_DR Cross Street: TAUTEN\_CT Location: SE

ADA ID: C58EDAB807D4 Ramp Type: PerpDiag Initial Pass/Fail: Pass Overall Compliance: No Severity Score: 21.5

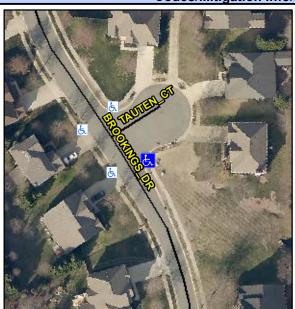
Compliance Description Data Compliance Description Data Yes N/A Ramp Length (in) 52.0 Ramp Slope (%) 5.7 Yes Ramp XSlope (%) Yes Ramp Width (in) 48.0 1.7 N/A Flare Type LT Sloped N/A Flare Type RT N/A N/A N/A Flare Slope RT (%) Flare Slope LT (%) 9.6 12.9 N/A Flare Traversable LT? No N/A Flare Traversable RT? No No 44.0 No DWS Provided? Landing Length (in) No No Landing Width (in) 35.0 N/A **DWS Contrast?** No N/A No Landing Slope (%) 3.5 DWS Length (in) N/A N/A No Landing X Slope (%) 3.0 DWS Full Width? No N/A Landing Curb? (Y/N) No N/A DWS Offset (in) N/A N/A Shared Landing? No Gutter Ponding? Yes Gutter Slope (%) No Yes 0.6 No Gutter Lip Ht (in) 0.5 Yes Gutter X Slope (%) 1.4 N/A Painted X Walk1? No N/A Painted X Walk2? No X Walk 1 Direction To W X Walk 2 Direction To N N/A N/A X Walk 1 Width (in) N/A X Walk 2 Width (in) N/A X Walk 1 Slope (%) X Walk 2 Slope (%) 7.0 3.8 X Walk 1 X Slope (%) 3.8 X Walk 2 X Slope (%) 2.9 N/A N/A N/A Ramp inside XWalk2? N/A Ramp inside XWalk1? Road Slope (%) 0.3 N/A Clear Space? Yes N/A Road X Slope (%) 6.0 Clear Space to XWalk (in) N/A No Yes Any Obstructions? Yes Storm Grate/Utility Hazard? No **Obstruction Type** Storm Grate/Utility Type

TATUTEN CT StopSign BROOKINGS DR None Remove & Replace Curb Ramp With Two New Directional Ramps or Equivalent. Grind Gutter Lip.

R304.2.1, R304.2.2-Perp, R304.3.2-Para, R304.5.3, R305, R302.7, R302.7.2

Total Cost: \$ 3400.00
