# Access Compliance Report

## Public Rights-of-Way

### (Curb Ramps)

Intersection ID: 17028	Main Street: MEADOWDALE_LN	Cross Street: MISSION_HILLS_RD	Location: NE
ADA ID: C593CBB11DA9	Ramp Type: PerpDiag	Initial Pass/Fail: Fail	Overall Compliance: No
Severity Score: 25			
Codes/Mitigation Info/Possible Solution		Field Measurements/Component Compliance

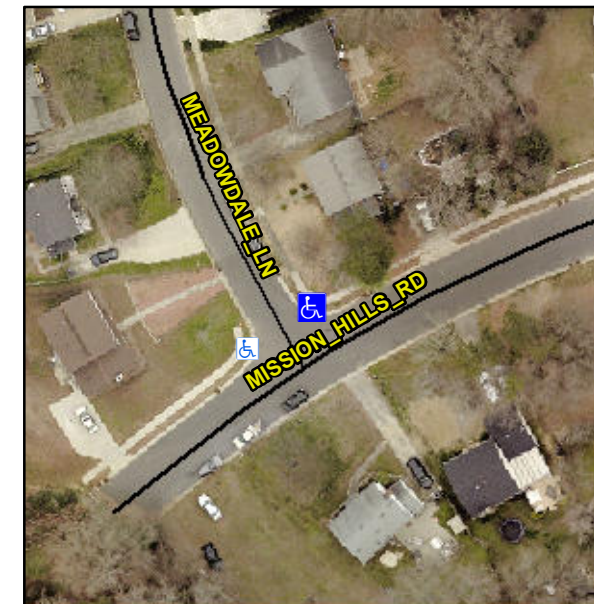
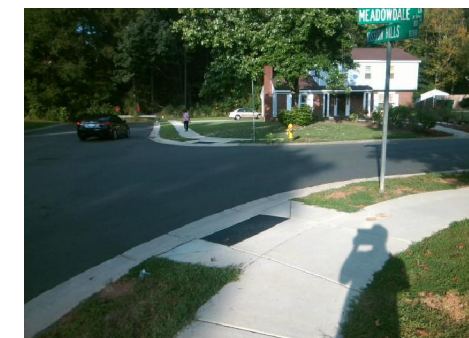
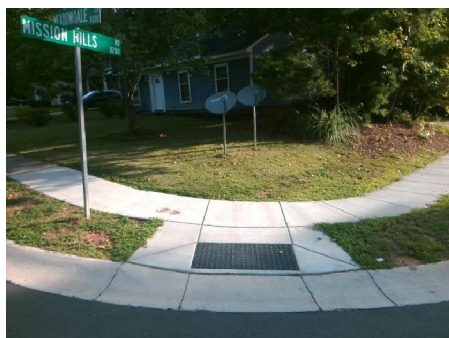
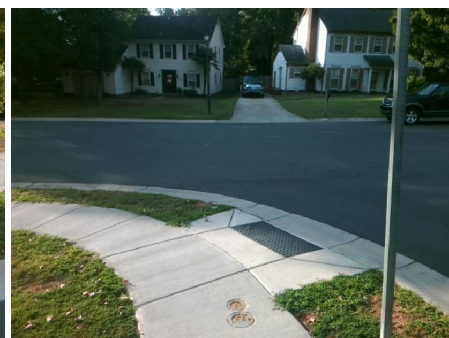
Compliance	Description	Data	Compliance	Description	Data
N/A	Ramp Length (in)	47.0	Yes	Ramp Slope (%)	7.6
Yes	Ramp Width (in)	48.0	No	Ramp XSlope (%)	7.6
N/A	Flare Type LT	N/A	N/A	Flare Type RT	N/A
N/A	Flare Slope LT (%)	N/A	N/A	Flare Slope RT (%)	N/A
N/A	Flare Traversable LT?	N/A	N/A	Flare Traversable RT?	N/A
N/A	Landing Length (in)	N/A	N/A	DWS Provided?	N/A
N/A	Landing Width (in)	N/A	N/A	DWS Contrast?	N/A
N/A	Landing Slope (%)	N/A	N/A	DWS Length (in)	N/A
N/A	Landing X Slope (%)	N/A	N/A	DWS Full Width?	N/A
N/A	Landing Curb? (Y/N)	N/A	N/A	DWS Offset (in)	N/A
N/A	Shared Landing?	N/A			
N/A	Gutter Ponding?	N/A	N/A	Gutter Slope (%)	N/A
N/A	Gutter Lip Ht (in)	N/A	N/A	Gutter X Slope (%)	N/A
N/A	Painted X Walk1?	No	N/A	Painted X Walk2?	No
	X Walk 1 Direction	To SW		X Walk 2 Direction	To SE
N/A	X Walk 1 Width (in)	N/A	N/A	X Walk 2 Width (in)	N/A
	X Walk 1 Slope (%)	4.7		X Walk 2 Slope (%)	1.2
	X Walk 1 X Slope (%)	4.2		X Walk 2 X Slope (%)	6.2

N/A	Ramp inside XWalk1?	N/A	N/A	Ramp inside XWalk2?	N/A
	Road Slope (%)	8.2	N/A	Clear Space?	N/A
	Road X Slope (%)	2.4	N/A	Clear Space to XWalk (in)	N/A
N/A	Any Obstructions?	N/A	N/A	Storm Grate/Utility Hazard?	N/A
	Obstruction Type			Storm Grate/Utility Type	
		N/A			N/A
		Yes		Surface Condition? (G/P)	Good

Possible Solutions:

**Remove & Replace Curb Ramp With Two New Directional Ramps or Equivalent.**

**Not Found, R304.5.3**

Total Cost: \$ 3200.00
