# Access Compliance Report

## Public Rights-of-Way

### (Curb Ramps)

Intersection ID: 3217	Main Street: CARVER_POND_RD	Cross Street: SPRING_PARK_DR	Location: N
ADA ID: C594C4EDCA6D	Ramp Type: PerpDiag	Initial Pass/Fail: Fail	Overall Compliance: No
			Severity Score: 36.25

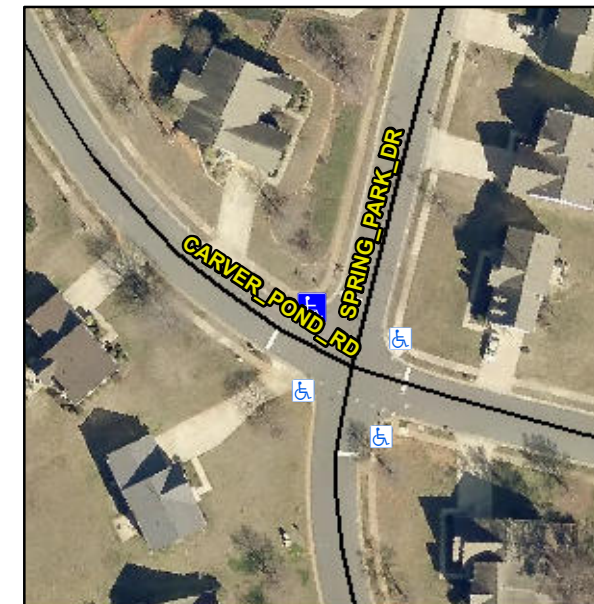
Compliance	Description	Data	Compliance	Description	Data
N/A	Ramp Length (in)	93.0	Yes	Ramp Slope (%)	5.0
No	Ramp Width (in)	31.0	No	Ramp XSlope (%)	4.5
N/A	Flare Type LT	N/A	N/A	Flare Type RT	N/A
N/A	Flare Slope LT (%)	N/A	N/A	Flare Slope RT (%)	N/A
N/A	Flare Traversable LT?	N/A	N/A	Flare Traversable RT?	N/A
N/A	Landing Length (in)	N/A	N/A	DWS Provided?	N/A
N/A	Landing Width (in)	N/A	N/A	DWS Contrast?	N/A
N/A	Landing Slope (%)	N/A	N/A	DWS Length (in)	N/A
N/A	Landing X Slope (%)	N/A	N/A	DWS Full Width?	N/A
N/A	Landing Curb? (Y/N)	N/A	N/A	DWS Offset (in)	N/A
N/A	Shared Landing?	N/A			
N/A	Gutter Ponding?	N/A	N/A	Gutter Slope (%)	N/A
N/A	Gutter Lip Ht (in)	N/A	N/A	Gutter X Slope (%)	N/A
N/A	Painted X Walk1?	No	N/A	Painted X Walk2?	No
	X Walk 1 Direction	To SW		X Walk 2 Direction	To SE
N/A	X Walk 1 Width (in)	N/A	N/A	X Walk 2 Width (in)	N/A
	X Walk 1 Slope (%)	0.8		X Walk 2 Slope (%)	2.7
	X Walk 1 X Slope (%)	4.9		X Walk 2 X Slope (%)	3.5

N/A	Ramp inside XWalk1?	N/A	N/A	Ramp inside XWalk2?	N/A
	Road Slope (%)	4.7	N/A	Clear Space?	N/A
	Road X Slope (%)	0.4	N/A	Clear Space to XWalk (in)	N/A
N/A	Any Obstructions?	N/A	N/A	Storm Grate/Utility Hazard?	N/A
	Obstruction Type			Storm Grate/Utility Type	
		N/A			N/A
			Yes	Surface Condition? (G/P)	Good

**Remove & Replace Curb Ramp With Two New Directional Ramps or Equivalent.**
