# Access Compliance Report

## Public Rights-of-Way

### (Curb Ramps)

Intersection ID: 13568	Main Street: ARLINGTON_AV	Cross Street: SOUTH_BV	Location:	N
ADA ID: C5965DF922D7	Ramp Type: Perp	Initial Pass/Fail: Fail	Overall Compliance: No	Severity Score: 1.25

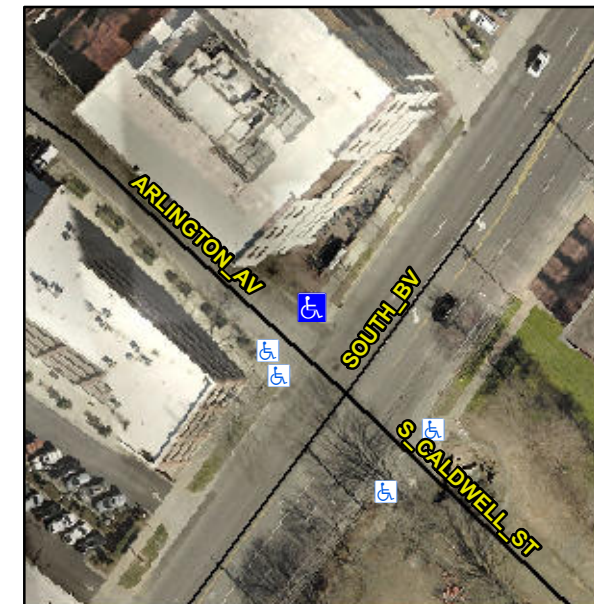
**Not Found, R304.5.3**

Compliance	Description	Data	Compliance	Description	Data
N/A	Ramp Length (in)	111.0	Yes	Ramp Slope (%)	5.3
Yes	Ramp Width (in)	69.0	No	Ramp XSlope (%)	2.6
N/A	Flare Type LT	N/A	N/A	Flare Type RT	N/A
N/A	Flare Slope LT (%)	N/A	N/A	Flare Slope RT (%)	N/A
N/A	Flare Traversable LT?	N/A	N/A	Flare Traversable RT?	N/A
N/A	Landing Length (in)	N/A	N/A	DWS Provided?	N/A
N/A	Landing Width (in)	N/A	N/A	DWS Contrast?	N/A
N/A	Landing Slope (%)	N/A	N/A	DWS Length (in)	N/A
N/A	Landing X Slope (%)	N/A	N/A	DWS Full Width?	N/A
N/A	Landing Curb? (Y/N)	N/A	N/A	DWS Offset (in)	N/A
N/A	Shared Landing?	N/A			
N/A	Gutter Ponding?	N/A	N/A	Gutter Slope (%)	N/A
N/A	Gutter Lip Ht (in)	N/A	N/A	Gutter X Slope (%)	N/A
N/A	Painted X Walk1?	No	N/A	Painted X Walk2?	N/A
	X Walk 1 Direction	To SW		X Walk 2 Direction	N/A
N/A	X Walk 1 Width (in)	N/A	N/A	X Walk 2 Width (in)	N/A
	X Walk 1 Slope (%)	2.2		X Walk 2 Slope (%)	N/A
	X Walk 1 X Slope (%)	0.7		X Walk 2 X Slope (%)	N/A

**Remove & Replace Entire Ramp.**

Total Cost: \$ 1850.00
