Access Compliance Report

Public Rights-of-Way

(Curb Ramps)

Intersection ID: 47469	Main Street: KALISPELL_LN	Cross Street: ELENDIL_LN	Location: SE
ADA ID: C59BA9E9EC9A	Ramp Type: BlendTrans1	Initial Pass/Fail: Fail	Overall Compliance: No
Severity Score: 8.75			
Codes/Mitigation Info/Possible Solution		Field Measurements/Component Compliance

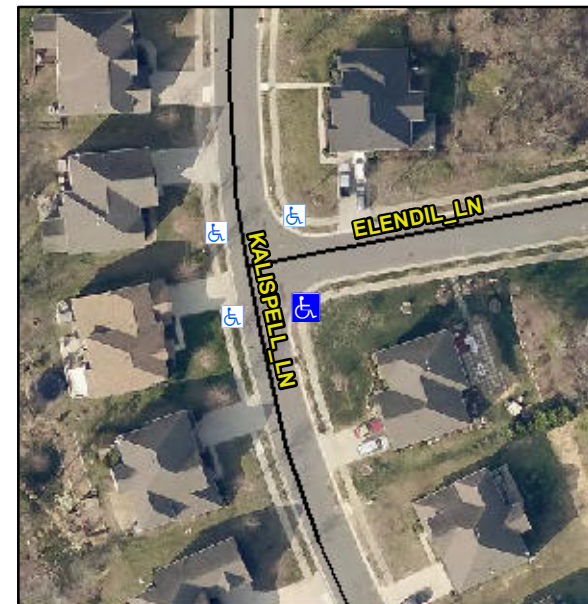
Not Found, R304.5.1

Compliance	Description	Data	Compliance	Description	Data
N/A	Ramp Length (in)	48.0	Yes	BlendTrans Slope (%)	1.5
No	Ramp Width (in)	47.0	Yes	BlendTrans XSlope (%)	0.8
N/A	Flare Type LT	N/A	N/A	Flare Type RT	N/A
N/A	Flare Slope LT (%)	N/A	N/A	Flare Slope RT (%)	N/A
N/A	Flare Traversable LT?	N/A	N/A	Flare Traversable RT?	N/A
N/A	Landing Length (in)	N/A	N/A	DWS Provided?	N/A
N/A	Landing Width (in)	N/A	N/A	DWS Contrast?	N/A
N/A	Landing Slope (%)	N/A	N/A	DWS Length (in)	N/A
N/A	Landing X Slope (%)	N/A	N/A	DWS Full Width?	N/A
N/A	Landing Curb? (Y/N)	N/A	N/A	DWS Offset (in)	N/A
N/A	Shared Landing?	N/A			
N/A	Gutter Ponding?	N/A	N/A	Gutter Slope (%)	N/A
N/A	Gutter Lip Ht (in)	N/A	N/A	Gutter X Slope (%)	N/A
N/A	Painted X Walk1?	No	N/A	Painted X Walk2?	No
	X Walk 1 Direction	To N		X Walk 2 Direction	To W
	X Walk 1 Width (in)	N/A		X Walk 2 Width (in)	N/A
	X Walk 1 Slope (%)	0.1		X Walk 2 Slope (%)	1.0
	X Walk 1 X Slope (%)	0.0		X Walk 2 X Slope (%)	2.2

N/A	Ramp inside XWalk1?	N/A	N/A	Ramp inside XWalk2?	N/A
	Road Slope (%)	1.5		Clear Space?	N/A
	Road X Slope (%)	2.2	N/A	Clear Space to XWalk (in)	N/A
N/A	Any Obstructions?	N/A	N/A	Storm Grate/Utility Hazard?	N/A
	Obstruction Type			Storm Grate/Utility Type	
		N/A			N/A
			Yes	Surface Condition? (G/P)	Good
			No	Curb Slope (%)	7.7

Possible Solutions:

Remove & Replace Curb Ramp With Two New Directional Ramps or Equivalent.
