# Access Compliance Report

## Public Rights-of-Way (Curb Ramps)

| Intersection ID: 10013231 | Main Street: MORNINGSIDE_DR | Cross Street: N/A | Location: E |
| ADA ID: C5AED7F9ECCB | Ramp Type: Perp | Initial Pass/Fail: Fail | Overall Compliance: No |

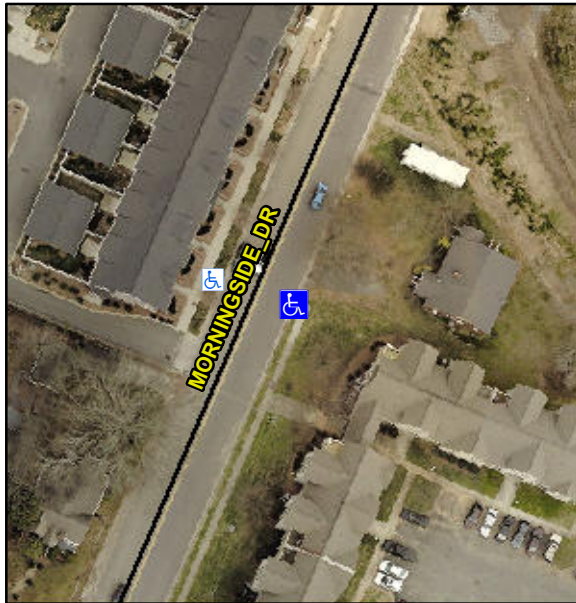
**Not Found, R304.2.2**

| Compliance | Description | Data | Compliance | Description | Data |
|---|---|---|---|---|---|
| N/A | Ramp Length (in) | 37.0 | No | Ramp Slope (%) | 14.8 |

**Remove & Replace Entire Ramp.**

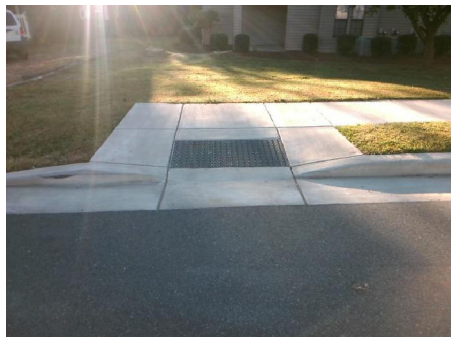
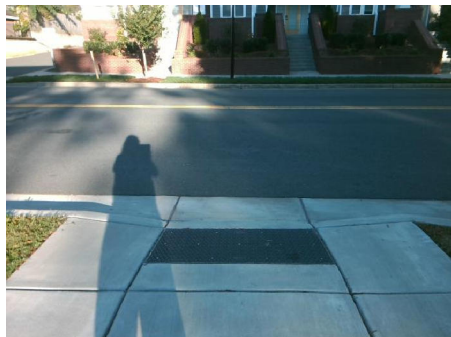
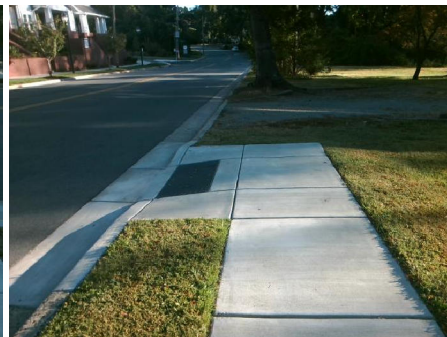
| Compliance | Description | Data | Compliance | Description | Data |
|---|---|---|---|---|---|
| Yes | Ramp Width (in) | 48.0 | Yes | Ramp XSlope (%) | 1.5 |
| | | | Yes | Surface Condition? (G/P) | Good |
