Access Compliance Report Public Rights-of-Way (Curb Ramps)

Main Street: MCKEE RD **Cross Street: N/A** Location: Intersection ID: N/A NE ADA ID: C5B1CE4BC076 Ramp Type: BlendTrans2 Initial Pass/Fail: Fail **Overall Compliance: No** 10 **Severity Score:**

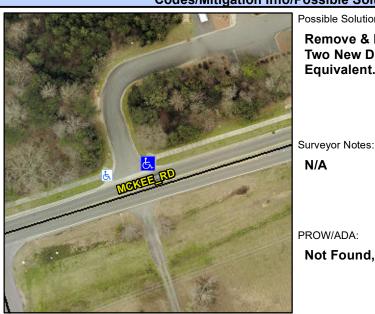
Compliance Description		Data	Comp	liance Description
N/A	Ramp Length (in)	122.0	Yes	BlendTrans Slope (%)
No	Ramp Width (in)	47.0	No	BlendTrans XSlope (%)
N/A	Flare Type LT	N/A	N/A	Flare Type RT
N/A	Flare Slope LT (%)	N/A	N/A	Flare Slope RT (%)
N/A	Flare Traversable LT?	N/A	N/A	Flare Traversable RT?
N/A	Landing Length (in)	N/A	N/A	DWS Provided?
N/A	Landing Width (in)	N/A	N/A	DWS Contrast?
N/A	Landing Slope (%)	N/A	N/A	DWS Length (in)
N/A	Landing X Slope (%)	N/A	N/A	DWS Full Width?
N/A	Landing Curb? (Y/N)	N/A	N/A	DWS Offset (in)
N/A	Shared Landing?	N/A		
N/A	Gutter Ponding?	N/A	N/A	Gutter Slope (%)
N/A	Gutter Lip Ht (in)	N/A	N/A	Gutter X Slope (%)
N/A	Painted X Walk1?	No	N/A	Painted X Walk2?
	X Walk 1 Direction	To W		X Walk 2 Direction
	X Walk 1 Width (in)	N/A		X Walk 2 Width (in)
	X Walk 1 Slope (%)	0.2		X Walk 2 Slope (%)
	X Walk 1 X Slope (%)	1.2		X Walk 2 X Slope (%)

Street 1 Name Stop Condition-Street 1 Street 2 Name Stop Condition-Street 2 Possible Solutions: Remove & Replace Curb Ramp With Two New Directional Ramps or Equivalent.

Not Found, R304.5.1, R304.5.3
