# Access Compliance Report

## Public Rights-of-Way

### (Curb Ramps)

| Intersection ID: N/A | Main Street: GRIFFITH_ST | Cross Street: FAIRWOOD_AV | Location: S |

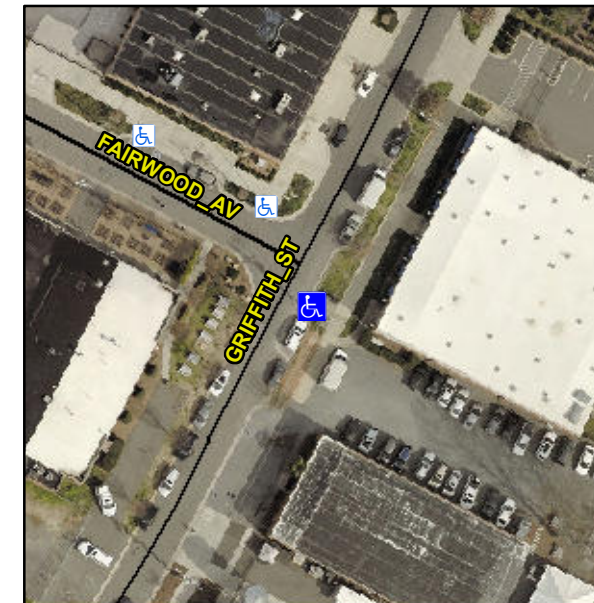
| ADA ID: C5C4A83C94B4 | Ramp Type: Perp | Initial Pass/Fail: Fail | Overall Compliance: No |

**Not Found, R304.2.2, R304.5.3**

| Compliance | Description | Data | Compliance | Description | Data |
|---|---|---|---|---|---|
| N/A | Ramp Length (in) | 80.0 | No | Ramp Slope (%) | 8.9 |
| Yes | Ramp Width (in) | 49.0 | No | Ramp XSlope (%) | 5.1 |

**Remove & Replace Entire Ramp.**

Total Cost: \$ 1850.00
