Access Compliance Report Public Rights-of-Way (Curb Ramps)

Intersection ID: 22956Main Street: CANOEBROOK_RDCross Street: QUAIL_HOLLOW_RDLocation:NEADA ID: C5FE4D9C14D8Ramp Type: PerpDiagInitial Pass/Fail: FailOverall Compliance: NoSeverity Score: 37.5

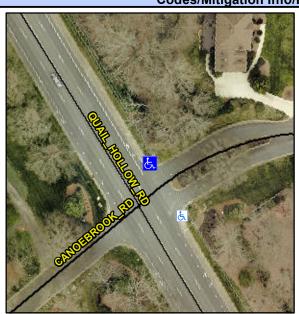
PROW/ADA:
Not Found, R304.2.2, R304.5.3

| Field Measurements/Component Compilance | | | | | |
|---|---|---|---|---|---|
| N/A | Ramp Length (in) | 59.0 | No | Ramp Slope (%) | 9.1 |
| Yes | Ramp Width (in) | 48.0 | No | Ramp XSlope (%) | 11.3 |

Remove & Replace Curb Ramp With
Two New Directional Ramps or
Equivalent.
