Access Compliance Report

Public Rights-of-Way

(Curb Ramps)

Intersection ID: 13823	Main Street: HANOVER_ST	Cross Street: COMMONWEALTH_AV	Location: E
ADA ID: C606C1B3BBD6	Ramp Type: Perp	Initial Pass/Fail: Fail	Overall Compliance: No
Severity Score: 10			
Codes/Mitigation Info/Possible Solution		Field Measurements/Component Compliance

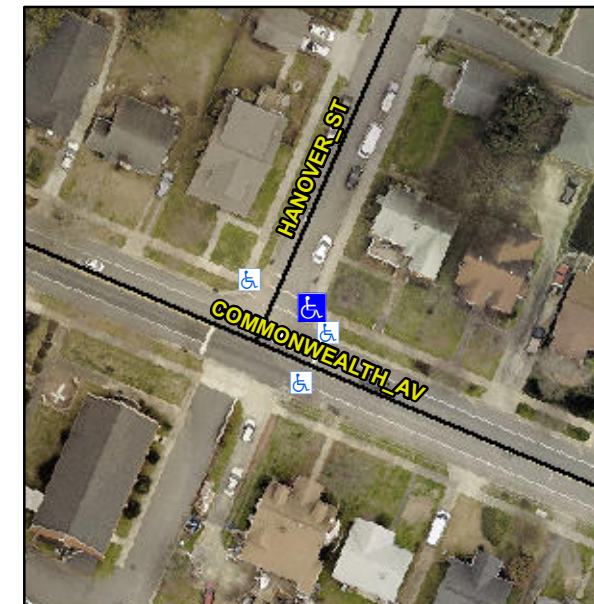
Not Found, R304.5.1, R304.5.3

Compliance	Description	Data	Compliance	Description	Data
N/A	Ramp Length (in)	72.0	Yes	Ramp Slope (%)	6.8
No	Ramp Width (in)	42.5	No	Ramp XSlope (%)	2.4
N/A	Flare Type LT	N/A	N/A	Flare Type RT	N/A
N/A	Flare Slope LT (%)	N/A	N/A	Flare Slope RT (%)	N/A
N/A	Flare Traversable LT?	N/A	N/A	Flare Traversable RT?	N/A
N/A	Landing Length (in)	N/A	N/A	DWS Provided?	N/A
N/A	Landing Width (in)	N/A	N/A	DWS Contrast?	N/A
N/A	Landing Slope (%)	N/A	N/A	DWS Length (in)	N/A
N/A	Landing X Slope (%)	N/A	N/A	DWS Full Width?	N/A
N/A	Landing Curb? (Y/N)	N/A	N/A	DWS Offset (in)	N/A
N/A	Shared Landing?	N/A			
N/A	Gutter Ponding?	N/A	N/A	Gutter Slope (%)	N/A
N/A	Gutter Lip Ht (in)	N/A	N/A	Gutter X Slope (%)	N/A
N/A	Painted X Walk1?	Yes	N/A	Painted X Walk2?	N/A
	X Walk 1 Direction	To NW		X Walk 2 Direction	N/A
N/A	X Walk 1 Width (in)	105.5	N/A	X Walk 2 Width (in)	N/A
	X Walk 1 Slope (%)	2.3		X Walk 2 Slope (%)	N/A
	X Walk 1 X Slope (%)	1.6		X Walk 2 X Slope (%)	N/A

N/A	Ramp inside XWalk1?	Yes	N/A	Ramp inside XWalk2?	N/A
	Road Slope (%)	N/A	N/A	Clear Space?	N/A
	Road X Slope (%)	N/A	N/A	Clear Space to XWalk (in)	N/A
N/A	Any Obstructions?	N/A	N/A	Storm Grate/Utility Hazard?	N/A
	Obstruction Type			Storm Grate/Utility Type	
		N/A			N/A
		Yes		Surface Condition? (G/P)	Good

Possible Solutions:

Remove & Replace Entire Ramp.
