Access Compliance Report

Public Rights-of-Way

(Curb Ramps)

Intersection ID: 3737	Main Street: CANTER_POST_DR	Cross Street: TROTTER_RD	Location:	E
ADA ID: C6100E67C0F9	Ramp Type: Perp	Initial Pass/Fail: Fail	Overall Compliance: No	Severity Score: 12.5
Codes/Mitigation Info/Possible Solution		Field Measurements/Component Compliance

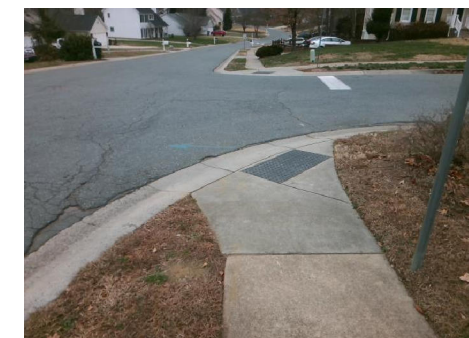
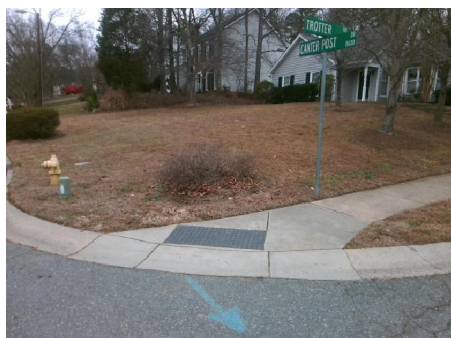
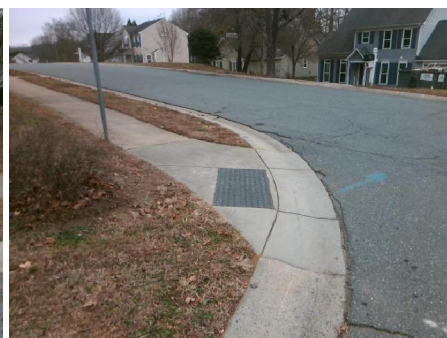
Not Found, R304.2.2

Compliance	Description	Data	Compliance	Description	Data
N/A	Ramp Length (in)	28.0	No	Ramp Slope (%)	8.8
Yes	Ramp Width (in)	48.0	Yes	Ramp XSlope (%)	1.6
N/A	Flare Type LT	N/A	N/A	Flare Type RT	N/A
N/A	Flare Slope LT (%)	N/A	N/A	Flare Slope RT (%)	N/A
N/A	Flare Traversable LT?	N/A	N/A	Flare Traversable RT?	N/A
N/A	Landing Length (in)	N/A	N/A	DWS Provided?	N/A
N/A	Landing Width (in)	N/A	N/A	DWS Contrast?	N/A
N/A	Landing Slope (%)	N/A	N/A	DWS Length (in)	N/A
N/A	Landing X Slope (%)	N/A	N/A	DWS Full Width?	N/A
N/A	Landing Curb? (Y/N)	N/A	N/A	DWS Offset (in)	N/A
N/A	Shared Landing?	N/A			
N/A	Gutter Ponding?	N/A	N/A	Gutter Slope (%)	N/A
N/A	Gutter Lip Ht (in)	N/A	N/A	Gutter X Slope (%)	N/A
N/A	Painted X Walk1?	No	N/A	Painted X Walk2?	N/A
	X Walk 1 Direction	To W		X Walk 2 Direction	N/A
N/A	X Walk 1 Width (in)	N/A	N/A	X Walk 2 Width (in)	N/A
	X Walk 1 Slope (%)	4.5		X Walk 2 Slope (%)	N/A
	X Walk 1 X Slope (%)	0.1		X Walk 2 X Slope (%)	N/A

Remove & Replace Entire Ramp.
