# Access Compliance Report

## Public Rights-of-Way

### (Curb Ramps)

Intersection ID: N/A	Main Street: NATIONAL_AV	Cross Street: POTOMAC_RIVER_PY	Location: S
ADA ID: C6130A5E00C2	Ramp Type: Directional1	Initial Pass/Fail: Fail	Overall Compliance: No
Severity Score: 13.75			
Codes/Mitigation Info/Possible Solution		Field Measurements/Component Compliance

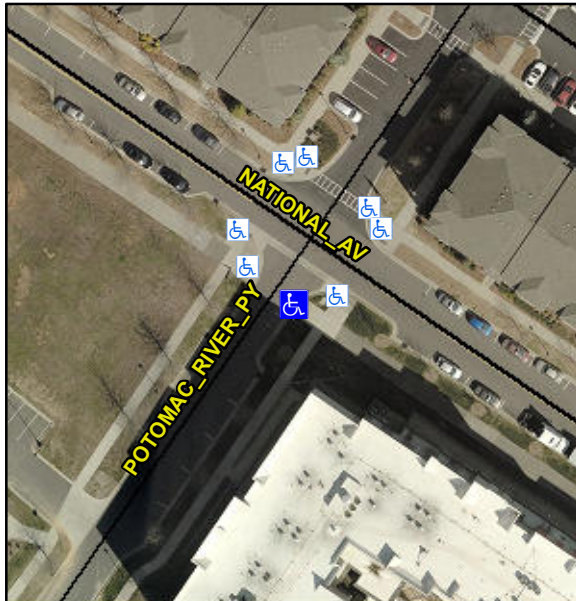
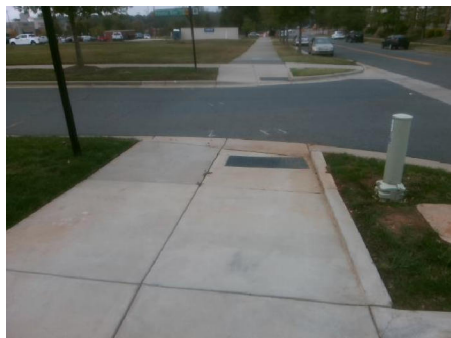
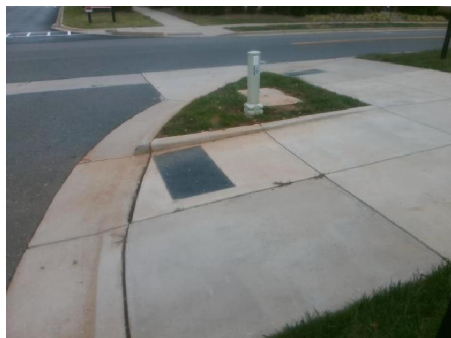
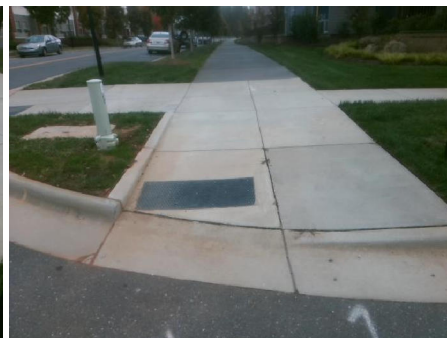
Compliance	Description	Data	Compliance	Description	Data
N/A	Ramp Length (in)	137.0	N/A	Grade Break?	N/A
Yes	Ramp Width (in)	58.0	N/A	Grade Break Slope (%)	0.0
No	Ramp Slope (%)	8.8	N/A	Grade Break XSlope (%)	0.0
No	Ramp XSlope (%)	3.7			
N/A	Flare Type LT	N/A	N/A	Flare Type RT	N/A
N/A	Flare Slope LT (%)	N/A	N/A	Flare Slope RT (%)	0.0
N/A	Flare Traversable LT?	N/A	N/A	Flare Traversable RT?	N/A
N/A	Landing Length (in)	0.0	N/A	DWS Provided?	N/A
N/A	Landing Width (in)	0.0	N/A	DWS Contrast?	N/A
N/A	Landing Slope (%)	0.0	N/A	DWS Length (in)	N/A
N/A	Landing X Slope (%)	0.0	N/A	DWS Full Width?	N/A
N/A	Landing Curb? (Y/N)	N/A	N/A	DWS Offset LT (in)	N/A
N/A	Shared Landing?	N/A	N/A	DWS Offset RT (in)	N/A
N/A	Gutter Ponding?	0.0	N/A	Gutter Slope (%)	N/A
N/A	Gutter Lip Ht (in)	0.0	N/A	Gutter X Slope (%)	N/A
N/A	Painted X Walk1?	No		Road Slope (%)	2.2
	X Walk 1 Direction	To W		Road X Slope (%)	0.2
	X Walk 1 Width (in)	N/A		Clear Space?	N/A

X Walk 1 Slope (%)	2.2	N/A	Clear Space to XWalk (in)	N/A
	X Walk 1 X Slope (%)	0.2	N/A	Storm Grate/Utility Hazard?	N/A
N/A	Ramp inside XWalk1?	N/A		Storm Grate/Utility Type	
N/A	Any Obstructions?	N/A			N/A
	Obstruction Type		Yes	Surface Condition? (G/P)	Good
			N/A	Curb Slope (%)	8.9

**Remove & Replace Entire Ramp.**

**R304.2.2, R304.5.3**
