Access Compliance Report

Public Rights-of-Way

(Curb Ramps)

Intersection ID: 21577	Main Street: SARDIS_CROSSING_DR	Cross Street: GALLERIA_BV	Location: NW
ADA ID: C626B68B71E1	Ramp Type: Perp	Initial Pass/Fail: Fail	Overall Compliance: No
Severity Score: 21.25			
Codes/Mitigation Info/Possible Solution		Field Measurements/Component Compliance

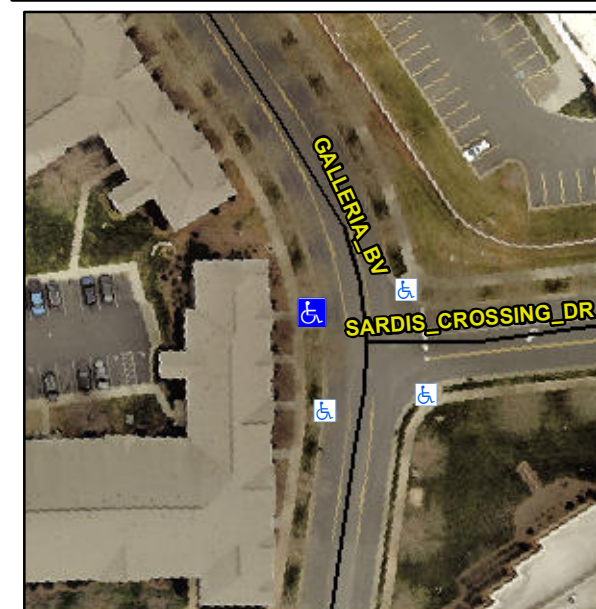
Not Found, R304.5.1, R304.2.2

Compliance	Description	Data	Compliance	Description	Data
N/A	Ramp Length (in)	94.0	No	Ramp Slope (%)	9.1
No	Ramp Width (in)	45.0	Yes	Ramp XSlope (%)	1.2
N/A	Flare Type LT	N/A	N/A	Flare Type RT	N/A
N/A	Flare Slope LT (%)	N/A	N/A	Flare Slope RT (%)	N/A
N/A	Flare Traversable LT?	N/A	N/A	Flare Traversable RT?	N/A
N/A	Landing Length (in)	N/A	N/A	DWS Provided?	N/A
N/A	Landing Width (in)	N/A	N/A	DWS Contrast?	N/A
N/A	Landing Slope (%)	N/A	N/A	DWS Length (in)	N/A
N/A	Landing X Slope (%)	N/A	N/A	DWS Full Width?	N/A
N/A	Landing Curb? (Y/N)	N/A	N/A	DWS Offset (in)	N/A
N/A	Shared Landing?	N/A			
N/A	Gutter Ponding?	N/A	N/A	Gutter Slope (%)	N/A
N/A	Gutter Lip Ht (in)	N/A	N/A	Gutter X Slope (%)	N/A
N/A	Painted X Walk1?	No	N/A	Painted X Walk2?	N/A
	X Walk 1 Direction	To E		X Walk 2 Direction	N/A
N/A	X Walk 1 Width (in)	N/A	N/A	X Walk 2 Width (in)	N/A
	X Walk 1 Slope (%)	1.1		X Walk 2 Slope (%)	N/A
	X Walk 1 X Slope (%)	3.8		X Walk 2 X Slope (%)	N/A

N/A	Ramp inside XWalk1?	N/A	N/A	Ramp inside XWalk2?	N/A
	Road Slope (%)	N/A	N/A	Clear Space?	N/A
	Road X Slope (%)	N/A	N/A	Clear Space to XWalk (in)	N/A
N/A	Any Obstructions?	N/A	N/A	Storm Grate/Utility Hazard?	N/A
	Obstruction Type			Storm Grate/Utility Type	
		N/A			N/A
			Yes	Surface Condition? (G/P)	Good

Possible Solutions:

Remove & Replace Entire Ramp.
