Access Compliance Report

Public Rights-of-Way

(Curb Ramps)

Intersection ID: 52716	Main Street: AGAVA_LN	Cross Street: MAIDENHAIR_CT	Location: SW
ADA ID: C635255F046D	Ramp Type: Perp	Initial Pass/Fail: Pass	Overall Compliance: No
Severity Score: 0			
Codes/Mitigation Info/Possible Solution		Field Measurements/Component Compliance

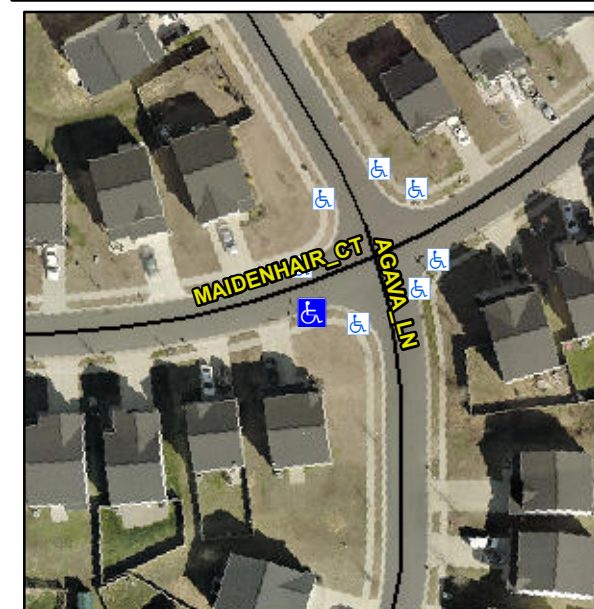
Not Found, R304.2.1

Compliance	Description	Data	Compliance	Description	Data
N/A	Ramp Length (in)	47.5	Yes	Ramp Slope (%)	5.5
Yes	Ramp Width (in)	48.0	Yes	Ramp XSlope (%)	0.5
N/A	Flare Type LT	Sloped	N/A	Flare Type RT	N/A
N/A	Flare Slope LT (%)	5.6	N/A	Flare Slope RT (%)	3.4
N/A	Flare Traversable LT?	No	N/A	Flare Traversable RT?	No
Yes	Landing Length (in)	48.0	Yes	DWS Provided?	Yes
No	Landing Width (in)	46.0	Yes	DWS Contrast?	Yes
Yes	Landing Slope (%)	1.2	Yes	DWS Length (in)	24.0
Yes	Landing X Slope (%)	1.2	Yes	DWS Full Width?	Yes
N/A	Landing Curb? (Y/N)	No	Yes	DWS Offset (in)	2.0
N/A	Shared Landing?	No			
Yes	Gutter Ponding?	No	Yes	Gutter Slope (%)	2.6
Yes	Gutter Lip Ht (in)	0.0	Yes	Gutter X Slope (%)	0.1
N/A	Painted X Walk1?	No	N/A	Painted X Walk2?	N/A
	X Walk 1 Direction	To N		X Walk 2 Direction	N/A
N/A	X Walk 1 Width (in)	N/A	N/A	X Walk 2 Width (in)	N/A
	X Walk 1 Slope (%)	3.1		X Walk 2 Slope (%)	N/A
	X Walk 1 X Slope (%)	2.7		X Walk 2 X Slope (%)	N/A

N/A	Ramp inside XWalk1?	N/A	N/A	Ramp inside XWalk2?	N/A
	Road Slope (%)	N/A	N/A	Clear Space?	Yes
	Road X Slope (%)	N/A	N/A	Clear Space to XWalk (in)	N/A
Yes	Any Obstructions?	No	Yes	Storm Grate/Utility Hazard?	No
	Obstruction Type			Storm Grate/Utility Type	
		N/A			N/A
			Yes	Surface Condition? (G/P)	Good

Possible Solutions:

Remove & Replace Entire Ramp.
