Access Compliance Report Public Rights-of-Way (Curb Ramps)

Intersection ID: 12428 Main Street: E_7TH_ST Cross Street: N_CALDWELL_ST Location: S

ADA ID: C64AB4F29DBE Ramp Type: PerpDiag Initial Pass/Fail: Fail Overall Compliance: No Severity Score: 13.75

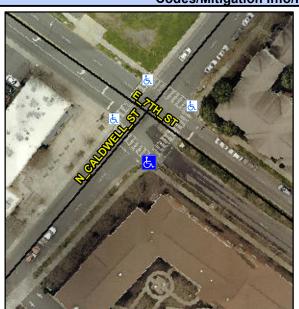
Field Measurements/Component Compliance							
	Compliance Description		Data	Compliance Description		Data	
	N/A	Ramp Length (in)	47.5	No	Ramp Slope (%)	10.0	
	Yes	Ramp Width (in)	50.0	Yes	Ramp XSlope (%)	4.8	
	N/A	Flare Type LT	N/A	N/A	Flare Type RT	N/A	
	N/A	Flare Slope LT (%)	N/A	N/A	Flare Slope RT (%)	N/A	
	N/A	Flare Traversable LT?	N/A	N/A	Flare Traversable RT?	N/A	
	N/A	Landing Length (in)	N/A	N/A	DWS Provided?	N/A	
	N/A	Landing Width (in)	N/A	N/A	DWS Contrast?	N/A	
	N/A	Landing Slope (%)	N/A	N/A	DWS Length (in)	N/A	
	N/A	Landing X Slope (%)	N/A	N/A	DWS Full Width?	N/A	
	N/A	Landing Curb? (Y/N)	N/A	N/A	DWS Offset (in)	N/A	
	N/A	Shared Landing?	N/A				
	N/A	Gutter Ponding?	N/A	N/A	Gutter Slope (%)	N/A	
	N/A	Gutter Lip Ht (in)	2.0	N/A	Gutter X Slope (%)	N/A	
	N/A	Painted X Walk1?	Yes	N/A	Painted X Walk2?	Yes	
		X Walk 1 Direction	To NE		X Walk 2 Direction	To NW	
	N/A	X Walk 1 Width (in)	105.0	N/A	X Walk 2 Width (in)	105.0

X Walk 1 Slope (%)	3.6		X Walk 2 Slope (%)	5.7	
		X Walk 1 X Slope (%)	7.0		X Walk 2 X Slope (%)	0.4	
	N/A	Ramp inside XWalk1?	Yes	N/A	Ramp inside XWalk2?	Yes	
		Road Slope (%)	5.9	N/A	Clear Space?	N/A	
		Road X Slope (%)	2.4	N/A	Clear Space to XWalk (in)	N/A	
	N/A	Any Obstructions?	N/A	N/A	Storm Grate/Utility Hazard?	N/A	
		Obstruction Type			Storm Grate/Utility Type		
			N/A			N/A	
				Yes	Surface Condition? (G/P)	Good	
_			'	•	,

Remove & Replace Curb Ramp With Two New Directional Ramps or Equivalent.

R304.2.2
