# Access Compliance Report

## Public Rights-of-Way

### (Curb Ramps)

Intersection ID: 29238	Main Street: POINTER RIDGE DR	Cross Street: WOODINGTON LN	Location: E
ADA ID: C65431965168	Ramp Type: PerpDiag	Initial Pass/Fail: Fail	Overall Compliance: No
Codes/Mitigation Info/Possible Solution		Field Measurements/Component Compliance	
Severity Score: 21.25

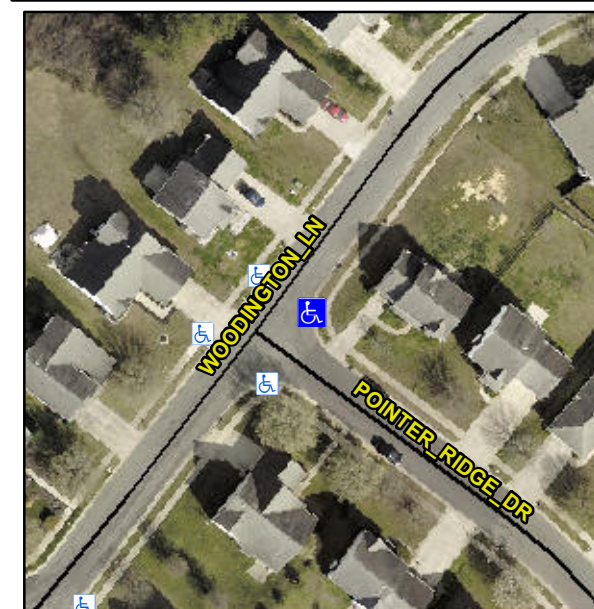
Compliance	Description	Data	Compliance	Description	Data
N/A	Ramp Length (in)	49.0	Yes	Ramp Slope (%)	6.6
No	Ramp Width (in)	46.0	No	Ramp XSlope (%)	6.1
N/A	Flare Type LT	N/A	N/A	Flare Type RT	N/A
N/A	Flare Slope LT (%)	N/A	N/A	Flare Slope RT (%)	N/A
N/A	Flare Traversable LT?	N/A	N/A	Flare Traversable RT?	N/A
N/A	Landing Length (in)	N/A	N/A	DWS Provided?	N/A
N/A	Landing Width (in)	N/A	N/A	DWS Contrast?	N/A
N/A	Landing Slope (%)	N/A	N/A	DWS Length (in)	N/A
N/A	Landing X Slope (%)	N/A	N/A	DWS Full Width?	N/A
N/A	Landing Curb? (Y/N)	N/A	N/A	DWS Offset (in)	N/A
N/A	Shared Landing?	N/A			
N/A	Gutter Ponding?	N/A	N/A	Gutter Slope (%)	N/A
N/A	Gutter Lip Ht (in)	N/A	N/A	Gutter X Slope (%)	N/A
N/A	Painted X Walk1?	No	N/A	Painted X Walk2?	No
	X Walk 1 Direction	To NW		X Walk 2 Direction	To SW
N/A	X Walk 1 Width (in)	N/A	N/A	X Walk 2 Width (in)	N/A
	X Walk 1 Slope (%)	1.7		X Walk 2 Slope (%)	4.6
	X Walk 1 X Slope (%)	5.5		X Walk 2 X Slope (%)	3.2

N/A	Ramp inside XWalk1?	N/A	N/A	Ramp inside XWalk2?	N/A
	Road Slope (%)	4.3	N/A	Clear Space?	N/A
	Road X Slope (%)	0.3	N/A	Clear Space to XWalk (in)	N/A
N/A	Any Obstructions?	N/A	N/A	Storm Grate/Utility Hazard?	N/A
	Obstruction Type			Storm Grate/Utility Type	
		N/A			N/A
			Yes	Surface Condition? (G/P)	Good

**Remove & Replace Curb Ramp With Two New Directional Ramps or Equivalent.**

**R304.5.1, R304.5.3**
