## **Access Compliance Report Public Rights-of-Way** (Curb Ramps)

Intersection ID: 27906 Main Street: BALLANTYNE COUNTRY CLUBrobs Street: HARRISON'S CROSSING AV Location: NE

**ADA ID: C65AEDDAF8C4** Ramp Type: PerpDiag Initial Pass/Fail: Fail **Overall Compliance: No** Severity Score: 13.75

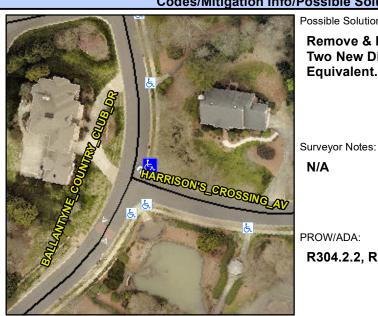
' '			' ' ' '
N/A	Flare Type LT	N/A	N/A	Flare Type RT
N/A	Flare Slope LT (%)	N/A	N/A	Flare Slope RT (%)
N/A	Flare Traversable LT?	N/A	N/A	Flare Traversable RT?
N/A	Landing Length (in)	N/A	N/A	DWS Provided?
N/A	Landing Width (in)	N/A	N/A	DWS Contrast?
N/A	Landing Slope (%)	N/A	N/A	DWS Length (in)
N/A	Landing X Slope (%)	N/A	N/A	DWS Full Width?
N/A	Landing Curb? (Y/N)	N/A	N/A	DWS Offset (in)
N/A	Shared Landing?	N/A		
N/A	Gutter Ponding?	N/A	N/A	Gutter Slope (%)
N/A	Gutter Lip Ht (in)	N/A	N/A	Gutter X Slope (%)
N/A	Painted X Walk1?	No	N/A	Painted X Walk2?
	X Walk 1 Direction	To NW		X Walk 2 Direction
N/A	X Walk 1 Width (in)	N/A	N/A	X Walk 2 Width (in)
	X Walk 1 Slope (%)	3.5		X Walk 2 Slope (%)
	X Walk 1 X Slope (%)	3.2		X Walk 2 X Slope (%)
N/A	Ramp inside XWalk1?	N/A	N/A	Ramp inside XWalk2?
	Road Slope (%)	4.3	N/A	Clear Space?
	Road X Slope (%)	0.3	N/A	Clear Space to XWalk (in)
N/A	Any Obstructions?	N/A	N/A	Storm Grate/Utility Hazard?

Possible Solutions: Remove & Replace Curb Ramp With Two New Directional Ramps or Equivalent.

R304.2.2, R304.5.3
