Access Compliance Report Public Rights-of-Way (Curb Ramps)

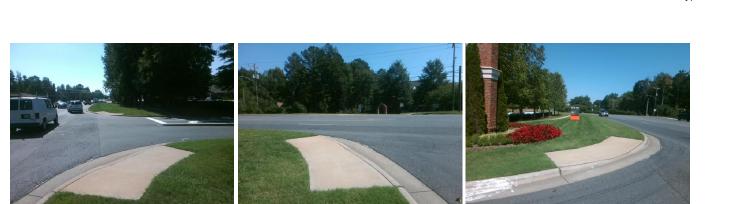
Interposition ID: 27112	Main Str			Cross	Stract				Location	NW
Intersection ID: 27113 Main Street: ALEXANDER_VALLEY_DR				Cross Street: PROVIDENCE_RD				Location:		
ADA ID: C6744CB68115 Ramp Type: PerpDiag			Initial F	nitial Pass/Fail: Fail Overall Compliance: No				o Severity Score:	33.75	
Codes/Mitigation Info/Possible Solution					Field Measurements/Component Compliance					
Sector 18 18	ANDER WALLEY DR	Possible Solutions:			Compliance Description		Data	Comp	liance Description	Data
		Remove & Replace Curb Ra	amp V	Vith	N/A	Ramp Length (in)	60.0	Yes	Ramp Slope (%)	5.3
		Two New Directional Ramps	s or		No	Ramp Width (in)	46.0	No	Ramp XSlope (%)	8.8
		Equivalent.			N/A	Flare Type LT	N/A	N/A	Flare Type RT	N/A
ALISTANDEL					N/A	Flare Slope LT (%)	N/A	N/A	Flare Slope RT (%)	N/A
					N/A	Flare Traversable LT?	N/A	N/A	Flare Traversable RT?	N/A
					N/A	Landing Length (in)	N/A	N/A	DWS Provided?	N/A
		Surveyor Notes:			N/A	Landing Width (in)	N/A	N/A	DWS Contrast?	N/A

# 1 3 B					N/A	Shared Landing?	N/A			
		PROW/ADA:			N/A	Gutter Ponding?	N/A	N/A	Gutter Slope (%)	N/A
ATRI PANA		Not Found, R304.5.1, R304.	.5.3		N/A	Gutter Lip Ht (in)	N/A	N/A	Gutter X Slope (%)	N/A
THAP AND A LA					N/A	Painted X Walk1?	No	N/A	Painted X Walk2?	No
						X Walk 1 Direction	To E		X Walk 2 Direction	To S
					N/A	X Walk 1 Width (in)	N/A	N/A	X Walk 2 Width (in)	N/A
Street 1 Name PROVII	DENCE RD					X Walk 1 Slope (%)	0.5		X Walk 2 Slope (%)	4.8
Stop Condition-Street 2	None					X Walk 1 X Slope (%)	14.1		X Walk 2 X Slope (%)	3.1
Street 2 Name E	INTRANCE				N/A	Ramp inside XWalk1?	N/A	N/A	Ramp inside XWalk2?	N/A
Stop Condition-Street 1	StopSign					Road Slope (%)	9.2	N/A	Clear Space?	N/A
						Road X Slope (%)	5.1	N/A	Clear Space to XWalk (in)	N/A
					N/A	Any Obstructions?	N/A	N/A	Storm Grate/Utility Hazard?	N/A
		Total Cost:	\$3	200.00		Obstruction Type			Storm Grate/Utility Type	
							N/A			N/A
