Access Compliance Report

Public Rights-of-Way

(Curb Ramps)

Intersection ID: 43839	Main Street: DELUCA_DR	Cross Street: HAMEL_ST	Location: SE
ADA ID: C6747682B18B	Ramp Type: BlendTrans1	Initial Pass/Fail: Fail	Overall Compliance: No
		Severity Score: 10

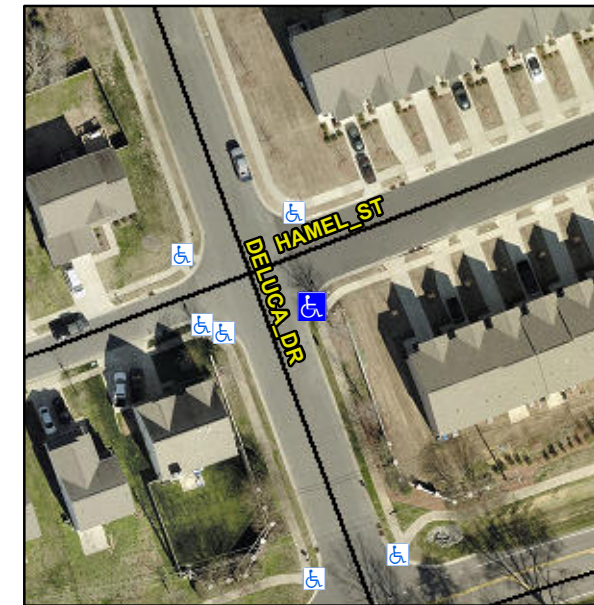
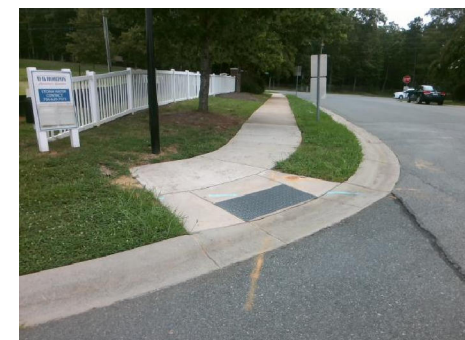
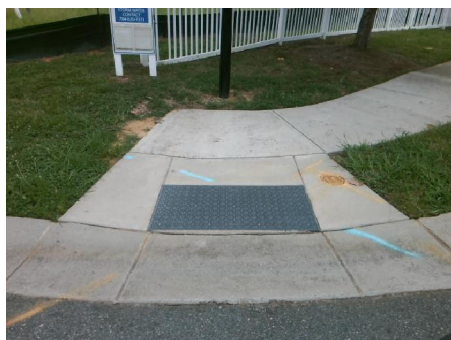
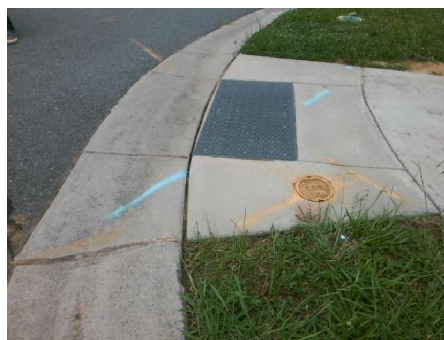
Not Found, R304.5.1, R304.5.3

Compliance	Description	Data	Compliance	Description	Data
N/A	Ramp Length (in)	46.0	Yes	BlendTrans Slope (%)	4.9
No	Ramp Width (in)	47.5	No	BlendTrans XSlope (%)	3.9
N/A	Flare Type LT	N/A	N/A	Flare Type RT	N/A
N/A	Flare Slope LT (%)	N/A	N/A	Flare Slope RT (%)	N/A
N/A	Flare Traversable LT?	N/A	N/A	Flare Traversable RT?	N/A
N/A	Landing Length (in)	N/A	N/A	DWS Provided?	N/A
N/A	Landing Width (in)	N/A	N/A	DWS Contrast?	N/A
N/A	Landing Slope (%)	N/A	N/A	DWS Length (in)	N/A
N/A	Landing X Slope (%)	N/A	N/A	DWS Full Width?	N/A
N/A	Landing Curb? (Y/N)	N/A	N/A	DWS Offset (in)	N/A
N/A	Shared Landing?	N/A			
N/A	Gutter Ponding?	N/A	N/A	Gutter Slope (%)	N/A
N/A	Gutter Lip Ht (in)	0.5	N/A	Gutter X Slope (%)	N/A
N/A	Painted X Walk1?	No	N/A	Painted X Walk2?	No
	X Walk 1 Direction	To N		X Walk 2 Direction	To W
	X Walk 1 Width (in)	N/A		X Walk 2 Width (in)	N/A
	X Walk 1 Slope (%)	1.8		X Walk 2 Slope (%)	4.2
	X Walk 1 X Slope (%)	5.3		X Walk 2 X Slope (%)	2.6

N/A	Ramp inside XWalk1?	N/A	N/A	Ramp inside XWalk2?	N/A
	Road Slope (%)	2.6		Clear Space?	N/A
	Road X Slope (%)	0.7	N/A	Clear Space to XWalk (in)	N/A
N/A	Any Obstructions?	N/A	N/A	Storm Grate/Utility Hazard?	N/A
	Obstruction Type			Storm Grate/Utility Type	
		N/A			N/A
			Yes	Surface Condition? (G/P)	Good
			No	Curb Slope (%)	10.0

Remove & Replace Curb Ramp With Two New Directional Ramps or Equivalent.
