Access Compliance Report

Public Rights-of-Way

(Curb Ramps)

Intersection ID: 3425	Main Street: ISLAND_COVE_LN	Cross Street: OVERLOOK_MOUNTAIN_DR	Location: NW
ADA ID: C680B783E485	Ramp Type: Perp	Initial Pass/Fail: Fail	Overall Compliance: No
Severity Score: 10			
Codes/Mitigation Info/Possible Solution		Field Measurements/Component Compliance

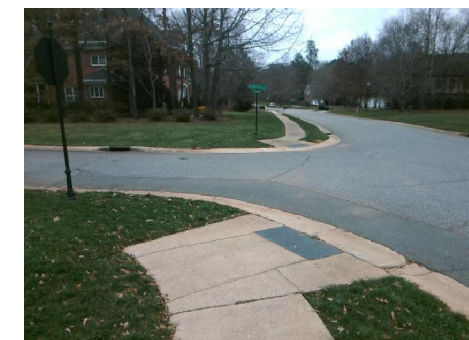
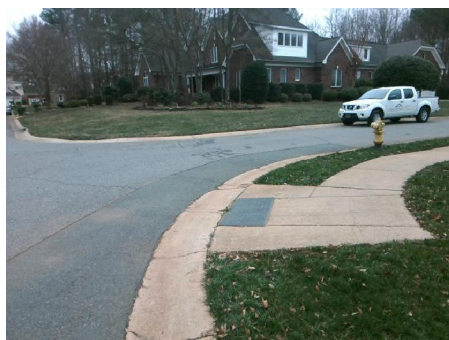
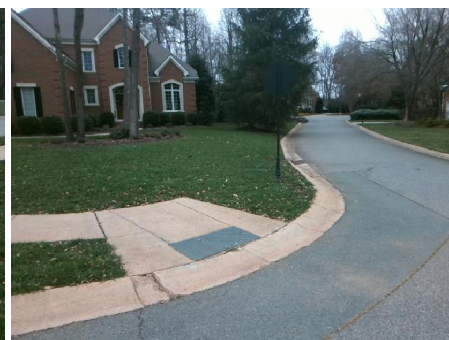
Not Found, R304.5.1, R304.5.3

Compliance	Description	Data	Compliance	Description	Data
N/A	Ramp Length (in)	97.0	Yes	Ramp Slope (%)	8.2
No	Ramp Width (in)	44.0	No	Ramp XSlope (%)	2.4
N/A	Flare Type LT	N/A	N/A	Flare Type RT	N/A
N/A	Flare Slope LT (%)	N/A	N/A	Flare Slope RT (%)	N/A
N/A	Flare Traversable LT?	N/A	N/A	Flare Traversable RT?	N/A
N/A	Landing Length (in)	N/A	N/A	DWS Provided?	N/A
N/A	Landing Width (in)	N/A	N/A	DWS Contrast?	N/A
N/A	Landing Slope (%)	N/A	N/A	DWS Length (in)	N/A
N/A	Landing X Slope (%)	N/A	N/A	DWS Full Width?	N/A
N/A	Landing Curb? (Y/N)	N/A	N/A	DWS Offset (in)	N/A
N/A	Shared Landing?	N/A			
N/A	Gutter Ponding?	N/A	N/A	Gutter Slope (%)	N/A
N/A	Gutter Lip Ht (in)	N/A	N/A	Gutter X Slope (%)	N/A
N/A	Painted X Walk1?	No	N/A	Painted X Walk2?	N/A
	X Walk 1 Direction	To E		X Walk 2 Direction	N/A
N/A	X Walk 1 Width (in)	N/A	N/A	X Walk 2 Width (in)	N/A
	X Walk 1 Slope (%)	1.8		X Walk 2 Slope (%)	N/A
	X Walk 1 X Slope (%)	0.6		X Walk 2 X Slope (%)	N/A

N/A	Ramp inside XWalk1?	N/A	N/A	Ramp inside XWalk2?	N/A
	Road Slope (%)	N/A	N/A	Clear Space?	N/A
	Road X Slope (%)	N/A	N/A	Clear Space to XWalk (in)	N/A
N/A	Any Obstructions?	N/A	N/A	Storm Grate/Utility Hazard?	N/A
	Obstruction Type			Storm Grate/Utility Type	
		N/A			N/A
			Yes	Surface Condition? (G/P)	Good

Remove & Replace Entire Ramp.

Total Cost: \$ 1850.00
