Access Compliance Report

Public Rights-of-Way

(Curb Ramps)

Intersection ID: 11256	Main Street: 5TH_ST	Cross Street: IRWIN_RD	Location: W
ADA ID: C6815C59C051	Ramp Type: Directional1	Initial Pass/Fail: Pass	Overall Compliance: No
Severity Score: 0			
Codes/Mitigation Info/Possible Solution		Field Measurements/Component Compliance

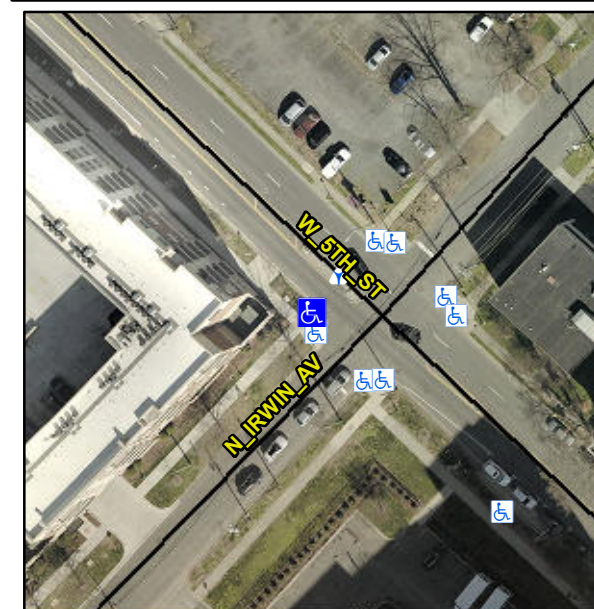
R304.5.3, R305.2

Compliance	Description	Data	Compliance	Description	Data
N/A	Ramp Length (in)	88.0	Yes	Grade Break?	Yes
Yes	Ramp Width (in)	70.0	No	Grade Break Slope (%)	7.0
Yes	Ramp Slope (%)	5.9	Yes	Grade Break XSlope (%)	0.9
Yes	Ramp XSlope (%)	0.3			
Yes	Flare Type LT	N/A	Yes	Flare Type RT	N/A
N/A	Flare Slope LT (%)	N/A	N/A	Flare Slope RT (%)	N/A
N/A	Flare Traversable LT?	No	N/A	Flare Traversable RT?	No
Yes	Landing Length (in)	72.0	Yes	DWS Provided?	Yes
Yes	Landing Width (in)	64.0	Yes	DWS Contrast?	Yes
Yes	Landing Slope (%)	0.2	Yes	DWS Length (in)	24.0
Yes	Landing X Slope (%)	1.2	Yes	DWS Full Width?	Yes
N/A	Landing Curb? (Y/N)	N/A	No	DWS Offset LT (in)	4.0
N/A	Shared Landing?	Yes	Yes	DWS Offset RT (in)	12.5
Yes	Gutter Ponding?	No	Yes	Gutter Slope (%)	2.7
Yes	Gutter Lip Ht (in)	0.0	Yes	Gutter X Slope (%)	0.7
N/A	Painted X Walk1?	No		Road Slope (%)	4.2
	X Walk 1 Direction	To NE		Road X Slope (%)	2.0
	X Walk 1 Width (in)	N/A		Clear Space?	Yes

X Walk 1 Slope (%)	4.2	N/A	Clear Space to XWalk (in)	N/A
	X Walk 1 X Slope (%)	2.0	Yes	Storm Grate/Utility Hazard?	No
N/A	Ramp inside XWalk1?	N/A		Storm Grate/Utility Type	
Yes	Any Obstructions?	No			N/A
	Obstruction Type		Yes	Surface Condition? (G/P)	Good
			N/A	Curb Slope (%)	3.5

Possible Solutions:

Remove & Replace Entire Ramp.

Total Cost: \$ 1600.00
