Access Compliance Report Public Rights-of-Way (Curb Ramps)

Intersection ID: 53633 Main Street: TREMONT RIDGE CT Cross Street: BEACON VALLEY ST Location: NE **Overall Compliance: No Severity Score:** 25 ADA ID: C682E8818792 Ramp Type: Perp Initial Pass/Fail: Fail

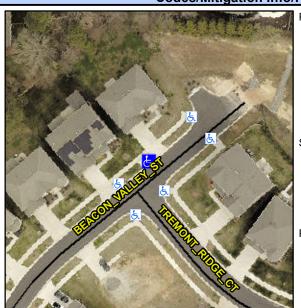
No Ramp XSlope (%) Yes Ramp Width (in) 59.0 N/A N/A Flare Type LT N/A Flare Type RT N/A N/A N/A Flare Slope RT (%) Flare Slope LT (%) N/A Flare Traversable LT? N/A N/A Flare Traversable RT? N/A N/A N/A **DWS Provided?** Landing Length (in) N/A Landing Width (in) N/A N/A **DWS Contrast?** N/A N/A N/A Landing Slope (%) DWS Length (in) N/A Landing X Slope (%) N/A N/A DWS Full Width? N/A Landing Curb? (Y/N) N/A N/A DWS Offset (in) N/A N/A Shared Landing? N/A **Gutter Ponding?** N/A N/A Gutter Slope (%) N/A Gutter Lip Ht (in) N/A N/A Gutter X Slope (%) N/A Painted X Walk1? No N/A Painted X Walk2? X Walk 1 Direction To SE X Walk 2 Direction N/A N/A X Walk 1 Width (in) X Walk 2 Width (in) X Walk 1 Slope (%) 0.1 X Walk 2 Slope (%) X Walk 1 X Slope (%) 9.0 X Walk 2 X Slope (%) N/A N/A N/A Ramp inside XWalk2? Ramp inside XWalk1? Road Slope (%) N/A N/A Clear Space? N/A Road X Slope (%) N/A Clear Space to XWalk (in) N/A N/A Any Obstructions? N/A Storm Grate/Utility Hazard? **Obstruction Type** Storm Grate/Utility Type

BEACON VALLEY ST Street 1 Name Stop Condition-Street 2 None N/A Street 2 Name Stop Condition-Street 1 N/A Possible Solutions: Compliance Description N/A Remove & Replace Entire Ramp. Surveyor Notes: N/A PROW/ADA: Not Found, R304.5.3
