Access Compliance Report

Public Rights-of-Way

(Curb Ramps)

| Intersection ID: 10023727 | Main Street: COLISEUM_CENTRE_DR | Cross Street: N/A | Location: E |

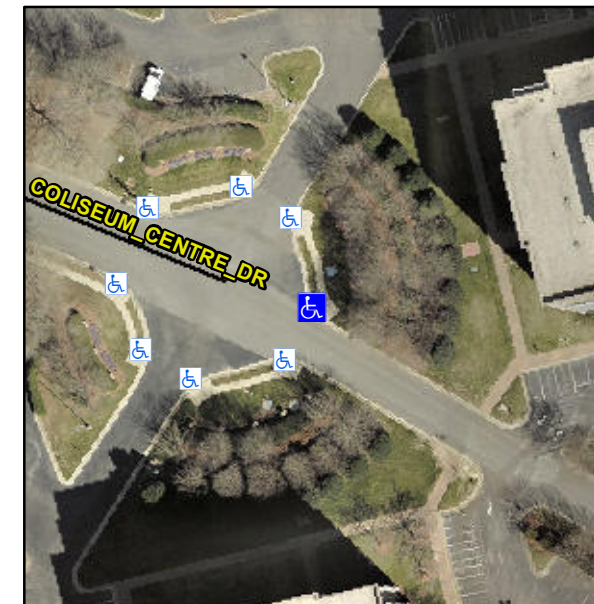
Not Found, R304.5.1, R304.5.3

| Compliance | Description | Data | Compliance | Description | Data |
|---|---|---|---|---|---|
| N/A | Ramp Length (in) | 96.0 | Yes | Ramp Slope (%) | 5.7 |
| No | Ramp Width (in) | 34.0 | No | Ramp XSlope (%) | 7.7 |

Remove & Replace Entire Ramp.
